**An analysis of channel change on the Rivers Tay and Tummel,  
Scotland, using GIS and remote sensing techniques.**

Sandra J. Winterbottom, BSc (Hons).

Department of Environmental Science,  
University of Stirling.

**Volume Two: figures and diagrams.**

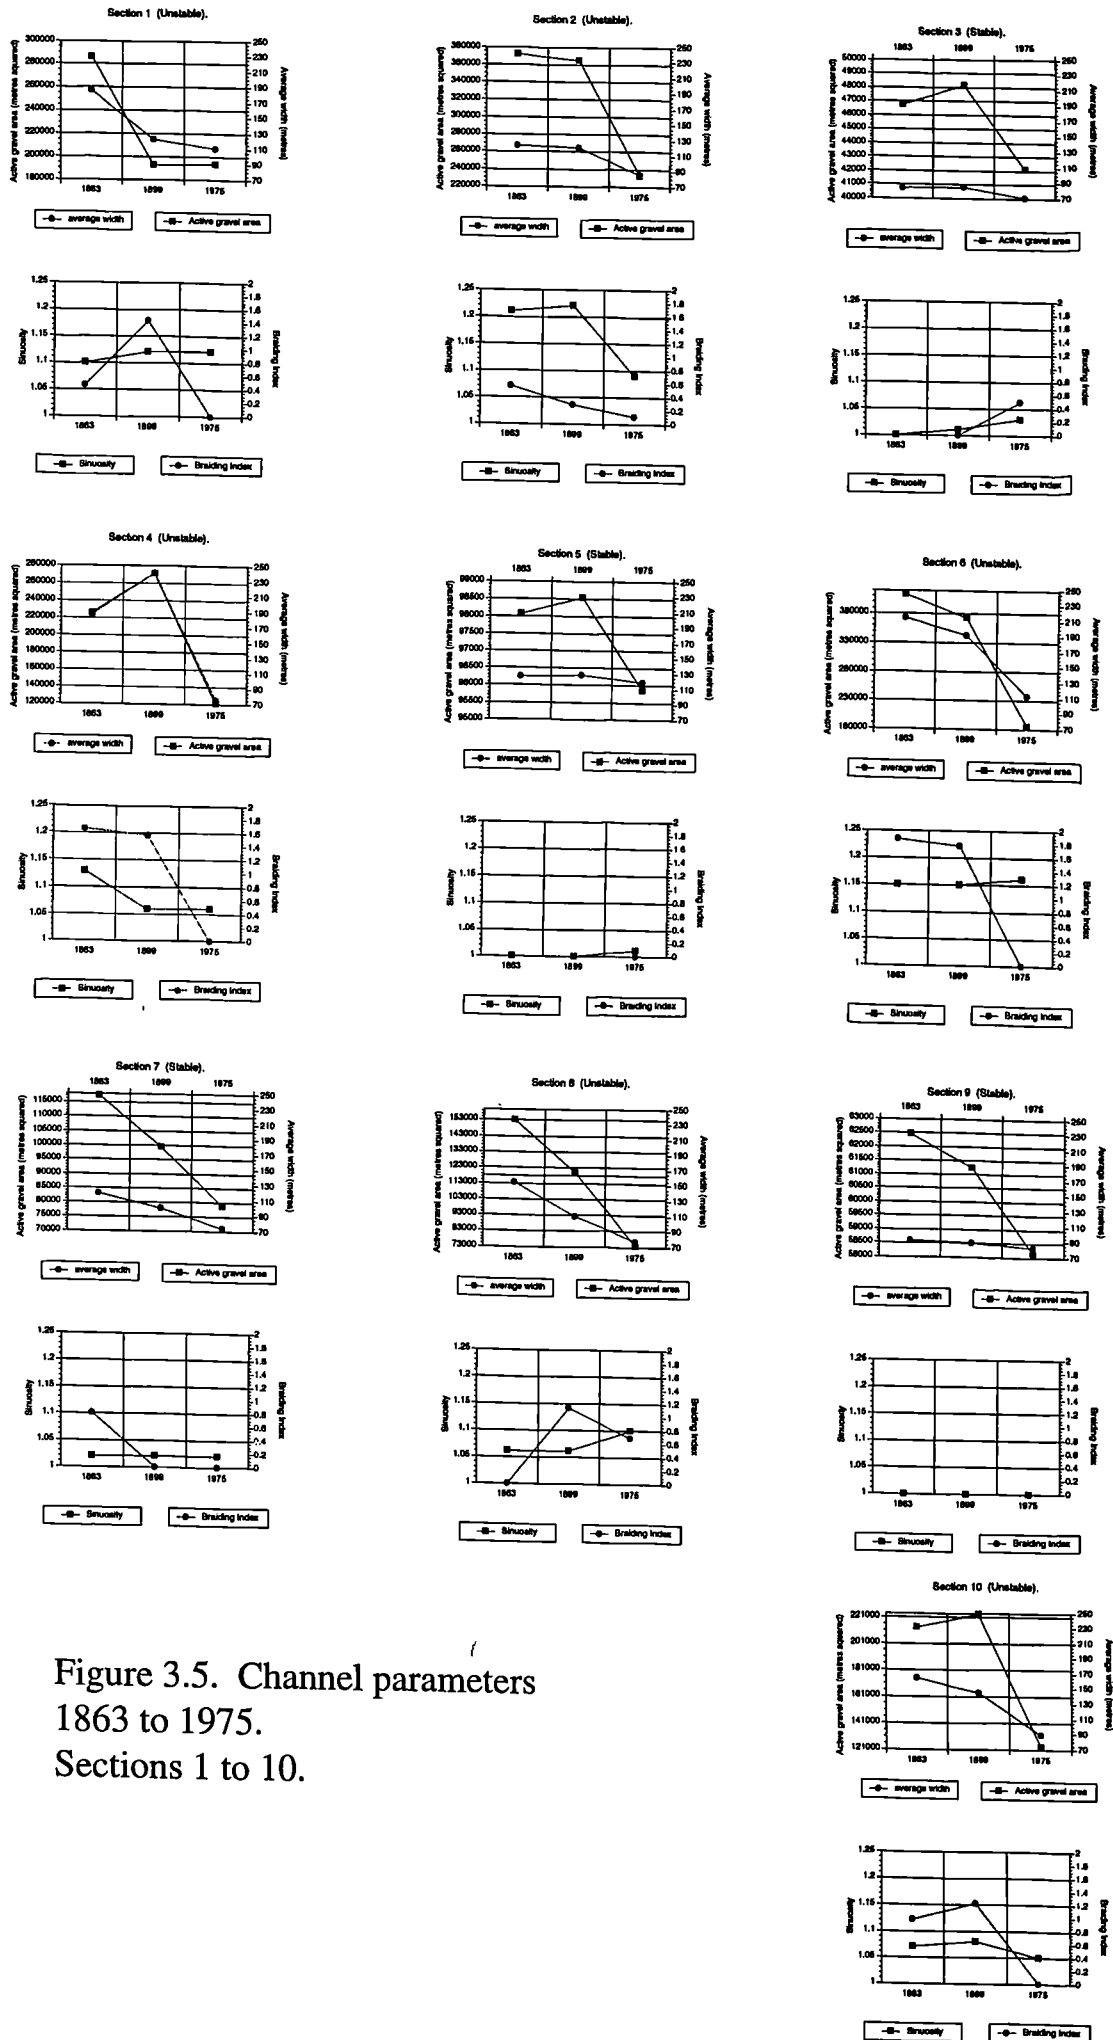
Figure 3.5. Channel parameters  
1863 to 1975.  
Sections 1 to 10.

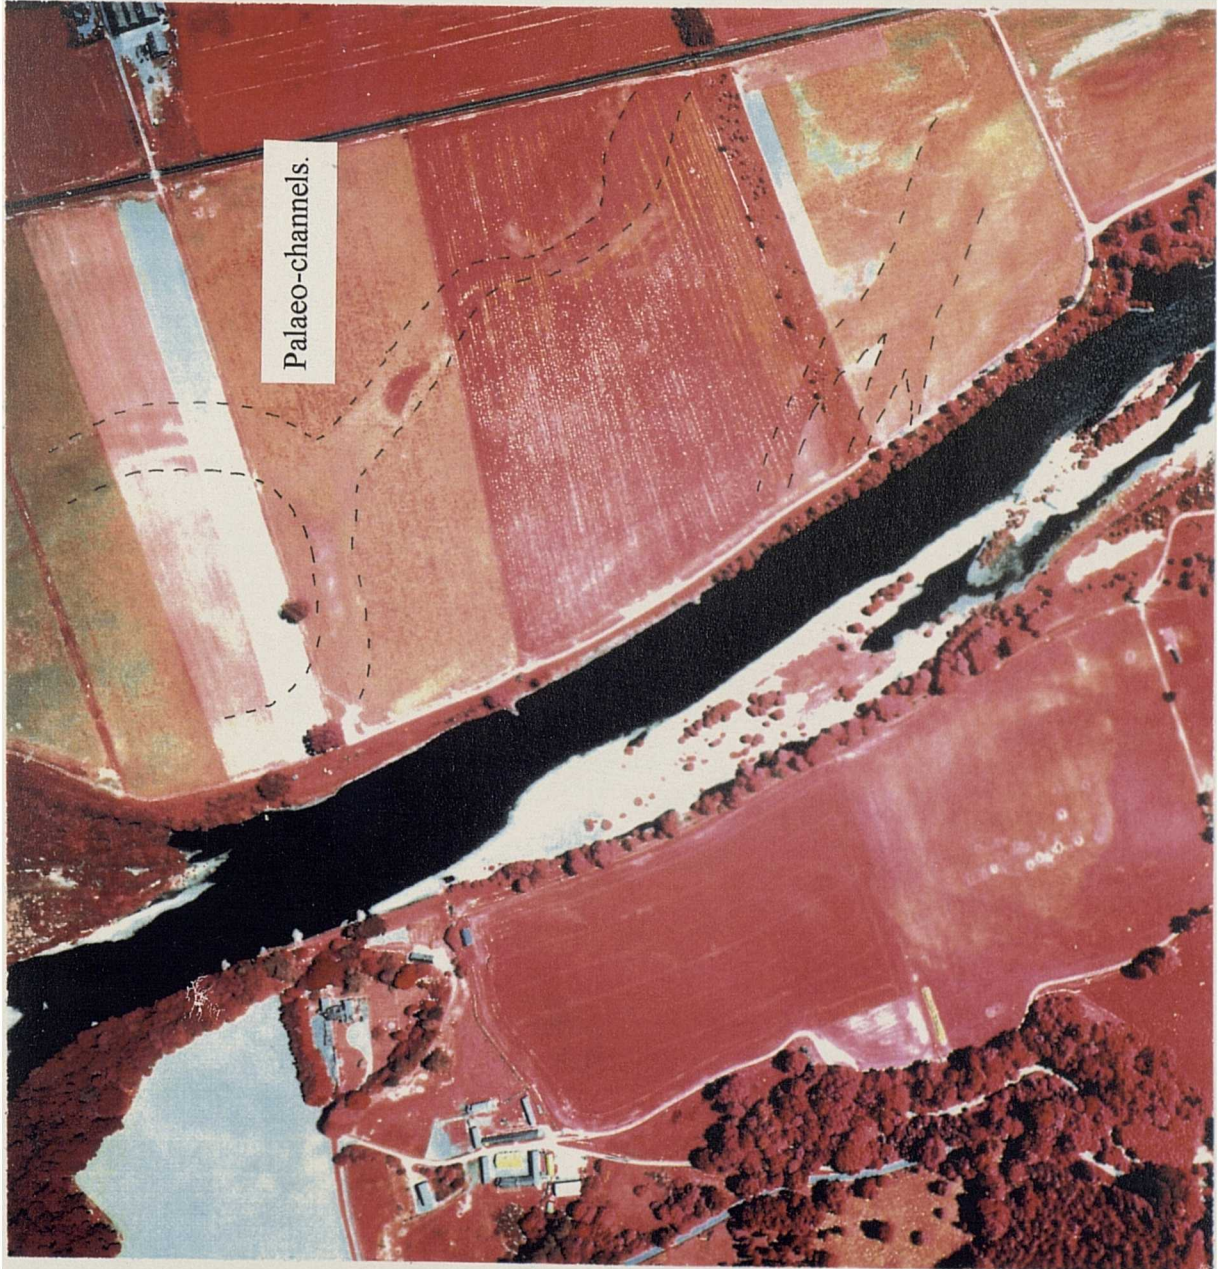
Plate 3.1. False colour infra-red  
aerial photograph showing floodplain  
sedimentary features.

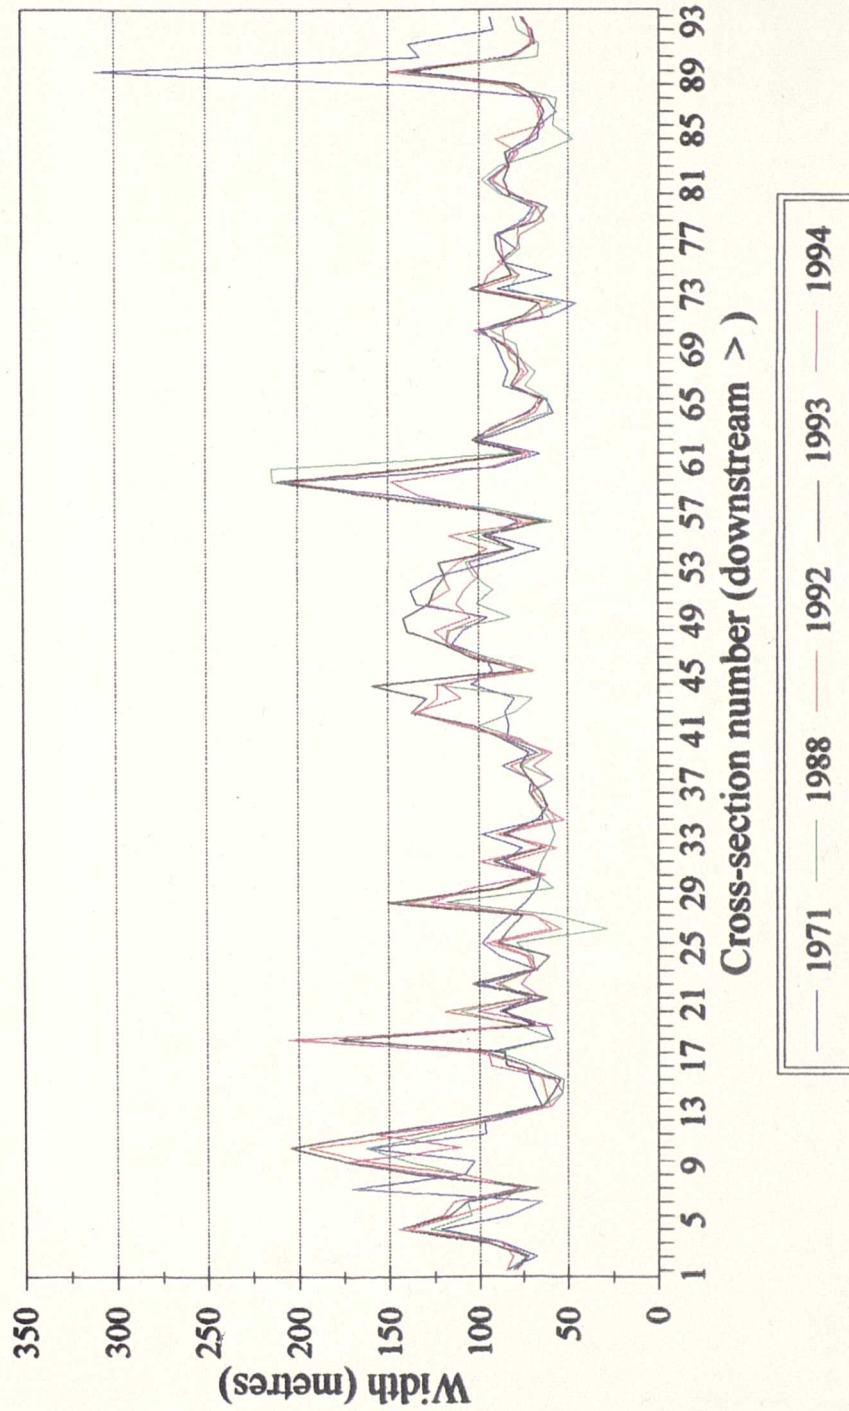
Figure 4.3. Average channel widths. 1971 to 1994.

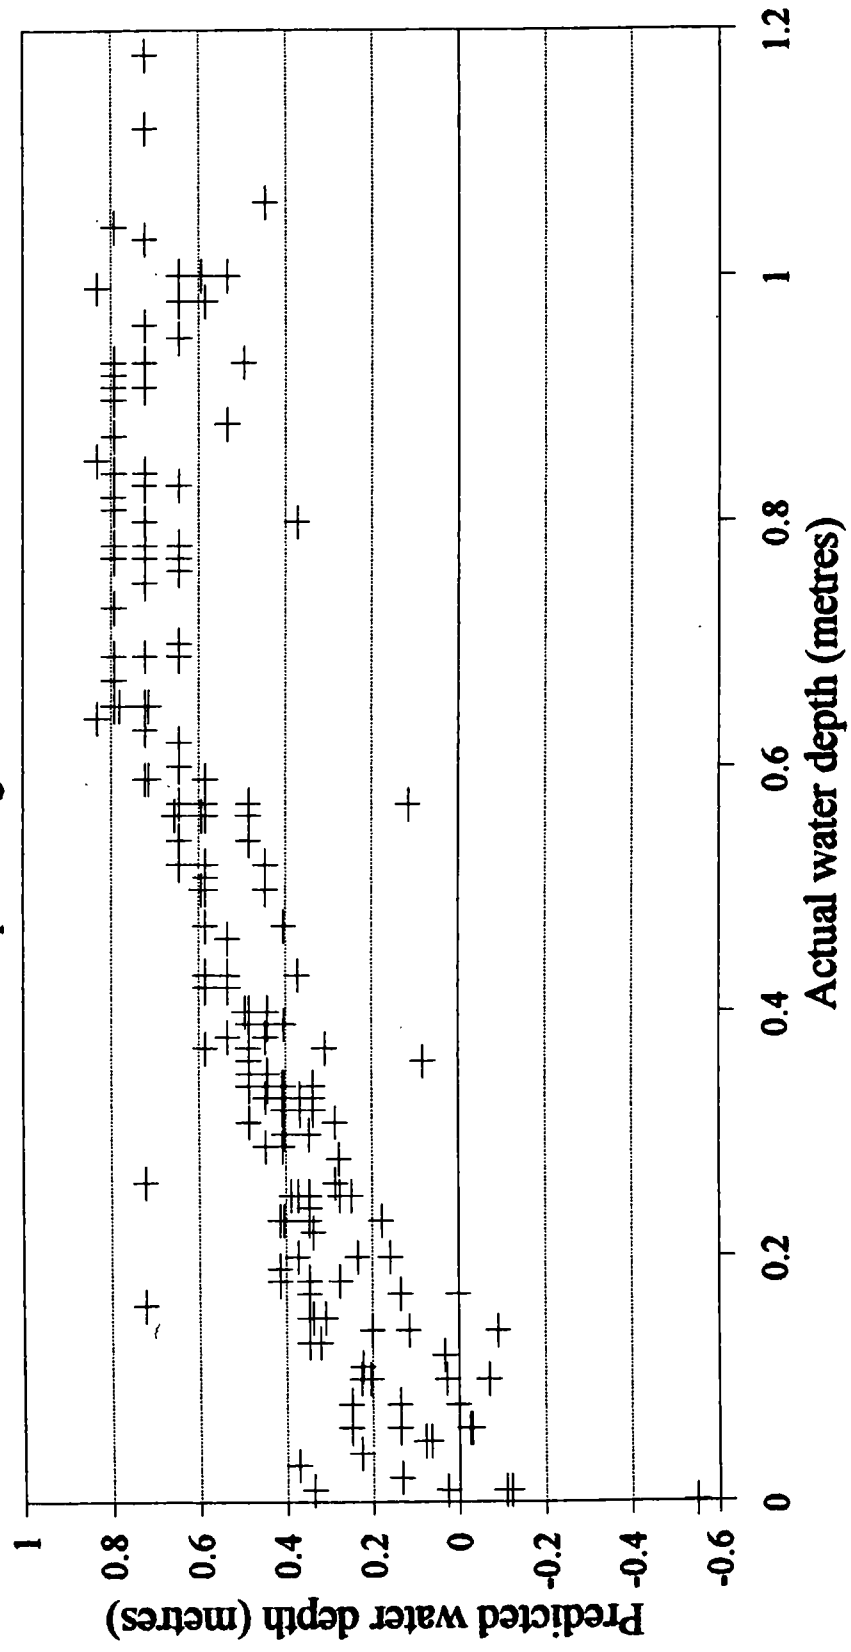
Figure 5.4. Depth classification using multiple regression of ATM bands 5, 6, 8 and 3. (r-squared=71.0%)

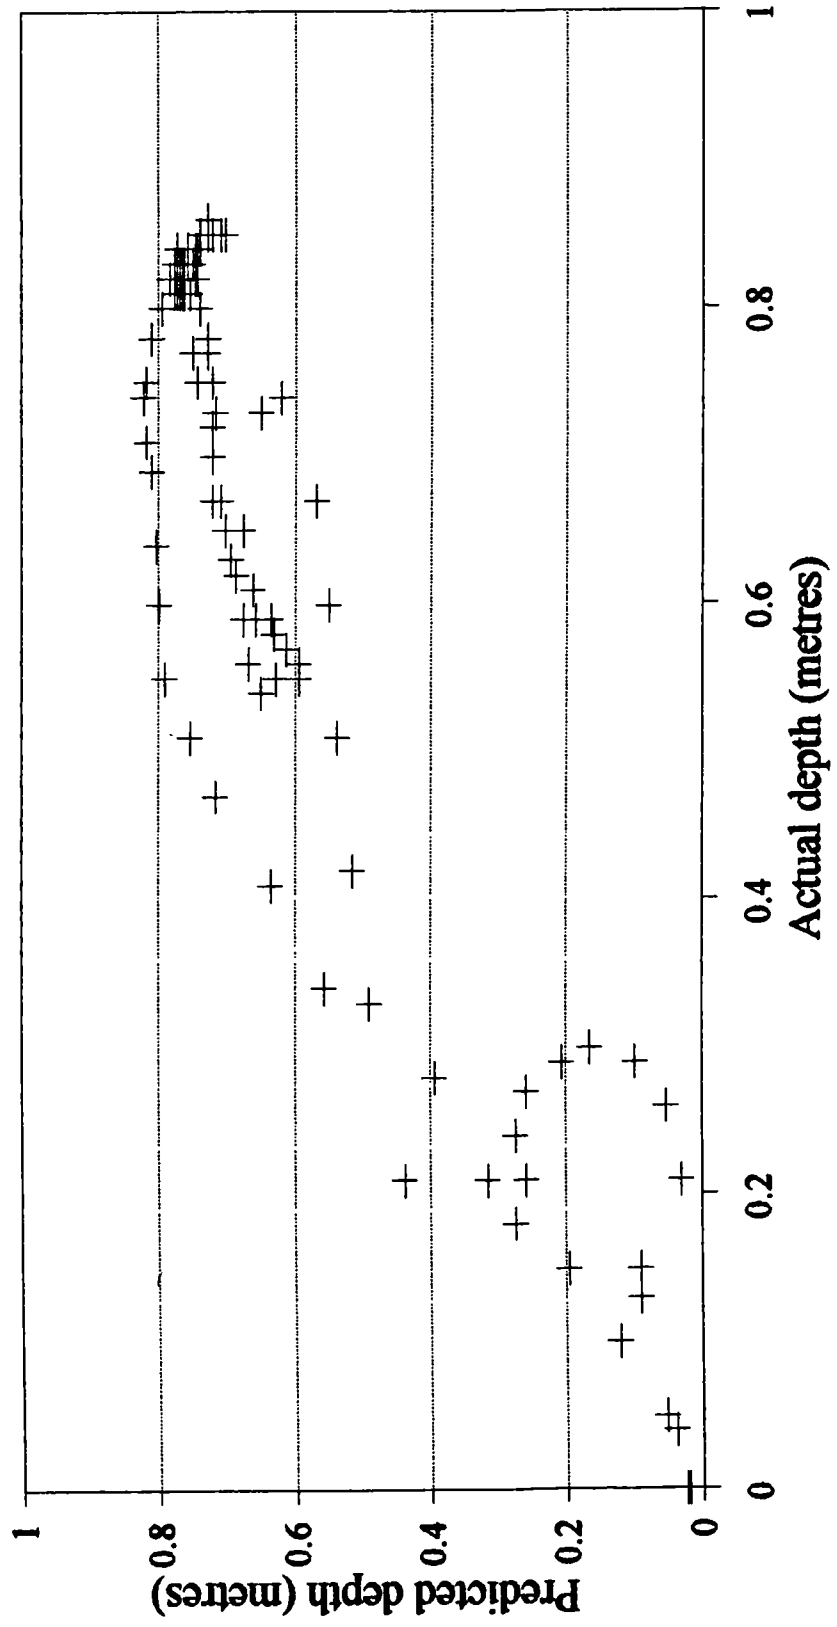
Figure 5.7.

River pool cross-section showing actual depths and predicted depths.

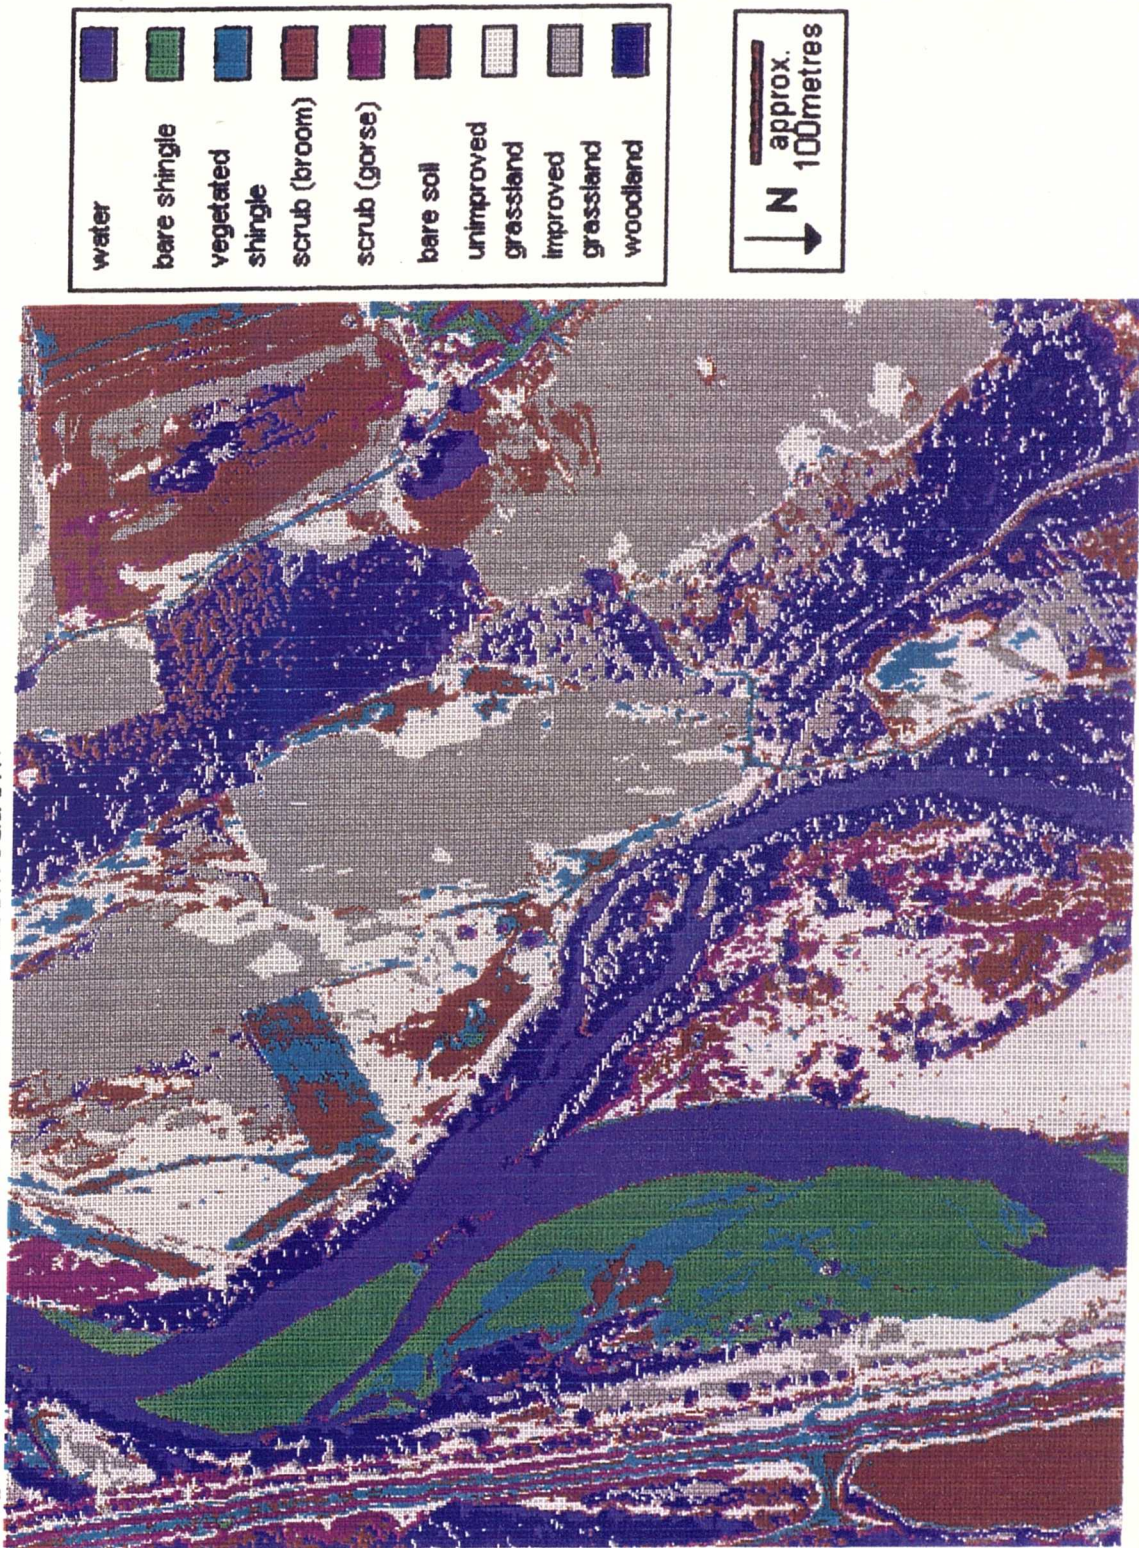
Figure 6.11. Maximum Likelihood Classification.
