Ground Penetrating Radar Survey

the Central Area between the Vestry and the Altar

2 External Areas overlying the former Lady Chapel

Dunfermline Abbey

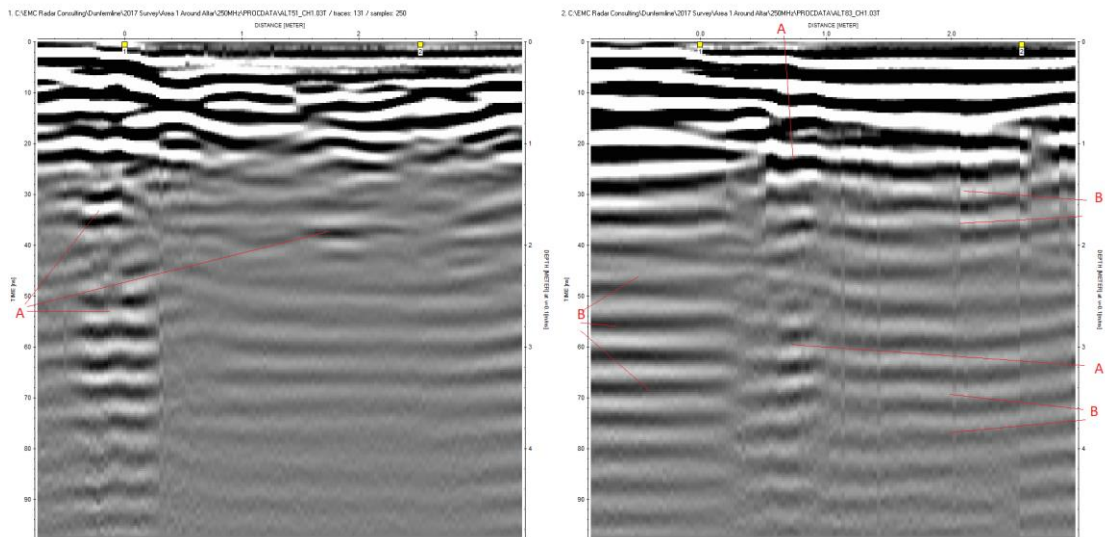
Figure 2: Survey Lines 51 and 83 (250MHz, Area 1)

The data in this area are characterised by a band of complicated signals within the first 20ns (c. 1m) of depth. This depth equates to the modern building rather than the archaeology and includes the known air gap. Below this there are relatively few signals although such as there are suggest large features (see Figure 2).

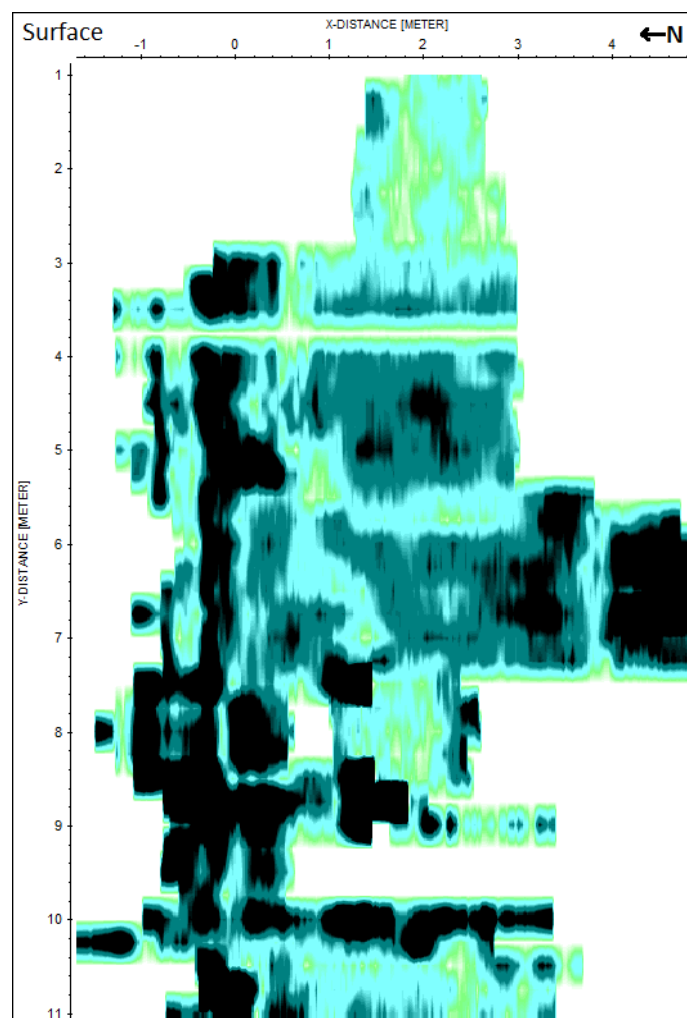
Figure 3: Time Slice at the Surface (250MHz, Area 1).

The thin white line running along $y = 3.75m$ in the time slices has no significance and should be ignored. Data from this line failed to record. The outline of the known tomb is not fully discernible as it proved possible to cross this feature. The small blank in the data towards the West indicate part of the position of this grave. The altar is located in the lowest central white strip.

It is possible that the dark area to the North is related to the proximity of air gaps beneath this floor given that the linear feature leads towards the Abbey organ.

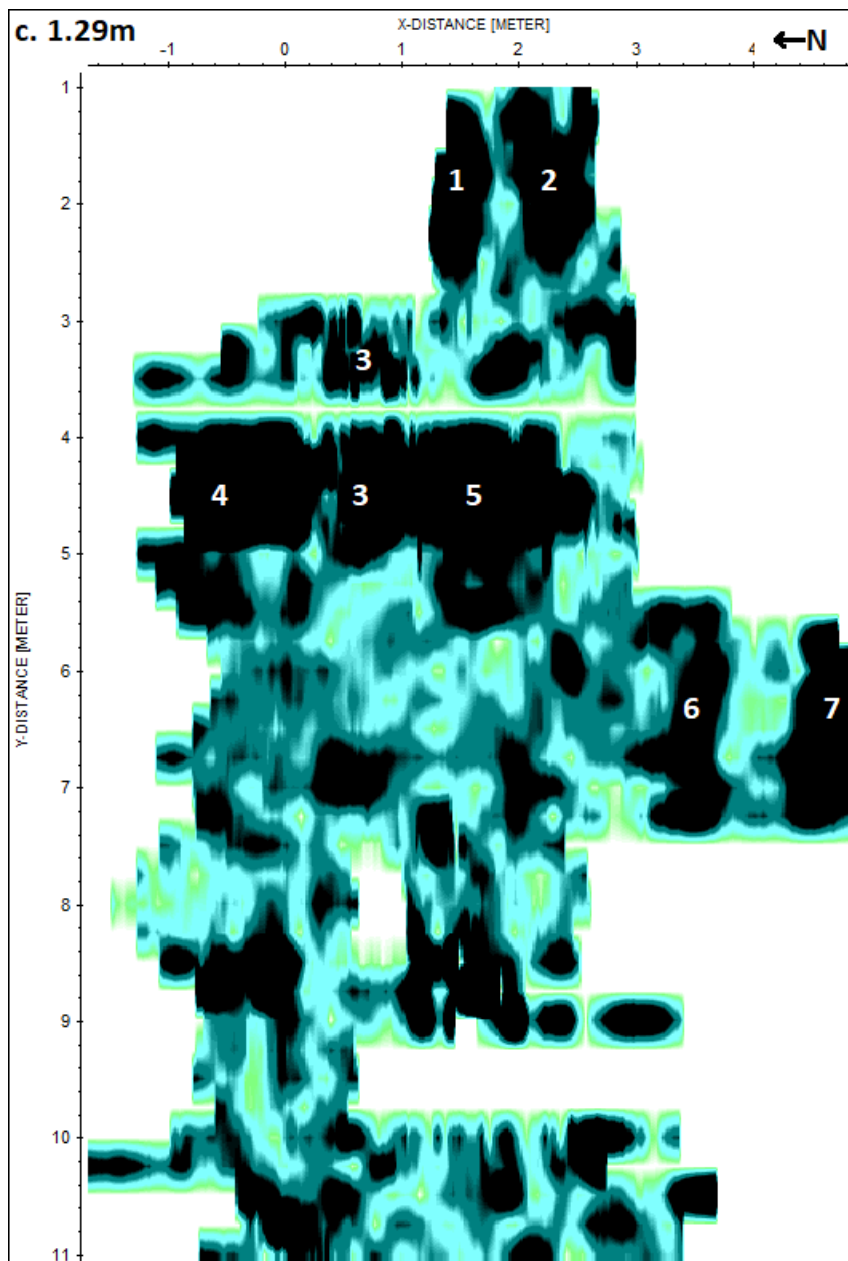
Figure 4: Time Slice at c. 1.29m (250MHz, Area 1).

Viewed in the vertical dimension, features 1 and 2 could potentially be air gaps (Figure 5). However, at this depth it is their lower extent which is being detected. It is difficult to separate out the black and white banding which marks these features from the smaller areas of strong signal lying directly above (Figure 5). As illustrated in the time slice, these do appear to be two individual features rather than one larger one although survey line 97 suggests that there could also be a third similar feature to the South.

This feature corresponds to feature 7 in the 250MHz data (see Figure 4). As noted previously, feature 7 is also visible covering a larger area at surface level (cf Figures 3 and 12) and also in the previous time slice (Figure 13).

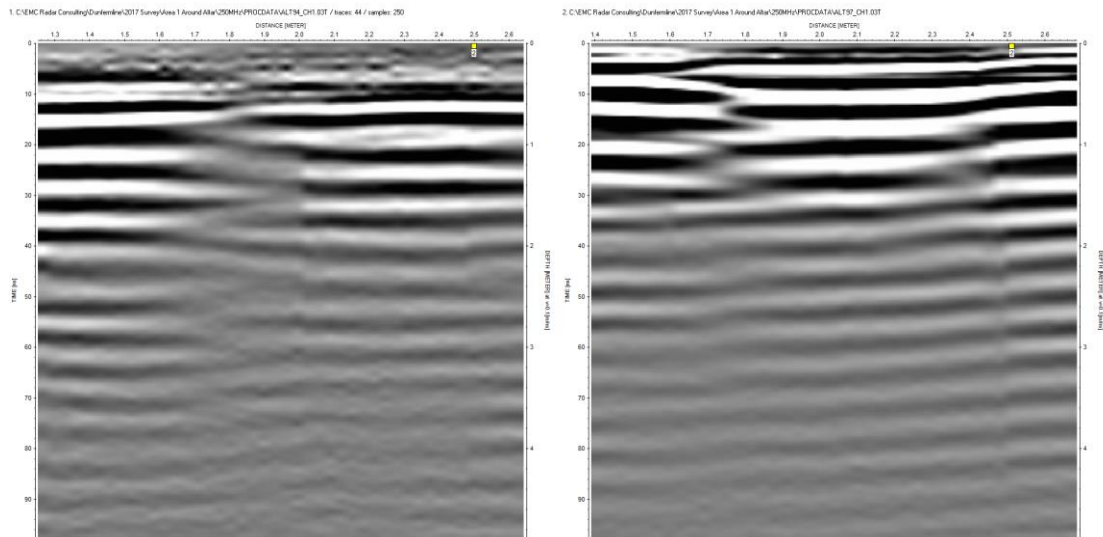
Figure 5: Survey lines 94 and 97 showing the vertical profile of Features 1 and 2 in Figure 4 (250MHz, Area 1).

Below these two features there are no further real signals. The banding which can be seen consists entirely of echo effects (ringing) from the strong signals above. Although ringing is often associated with air gaps, it can also be associated with the presence of metal although, typically, ringing from metal covers the full depth below the feature. The two features measure an approximate length of 1.7m and approximate width of 50 to 60cms and the ground beneath these potential air gaps is completely unsuited to GPR survey. If air is present, either within the possible graves or the features directly above them then it is likely that their actual depth is greater than this time slice suggests because radio waves travel three times faster through air than through dry soil.

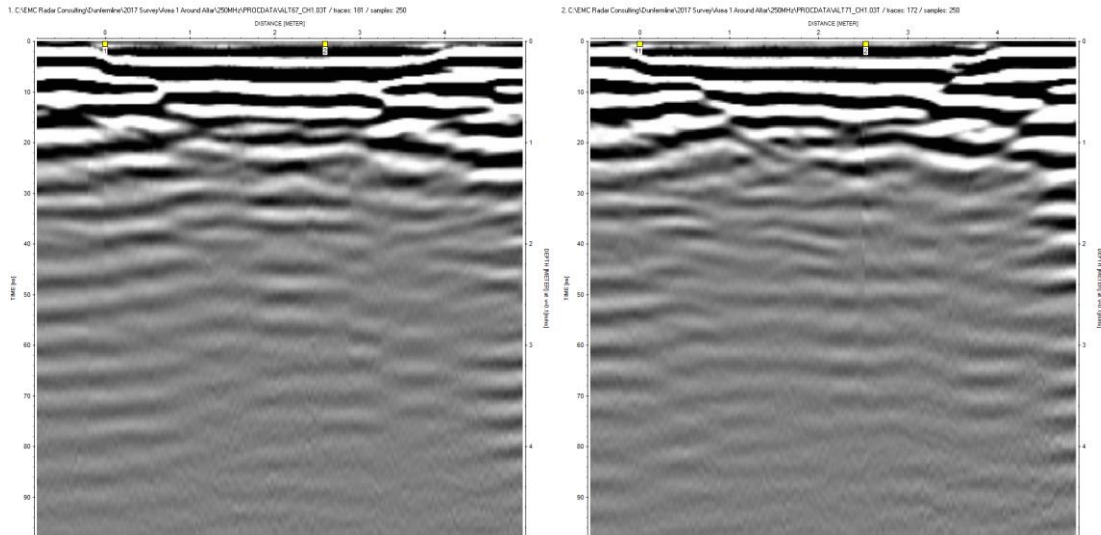
Figure 7: Survey Lines 67 and 71 showing the vertical profile of Features 6 and 7 in Figure 4 (250MHz, Area 1).

Features 6 and 7 also appear very similar in nature. There does not appear to be as much ringing below feature 6 but there is considerably more below feature 7 towards the southern edge of the survey area (cf rhs of Figure 7).

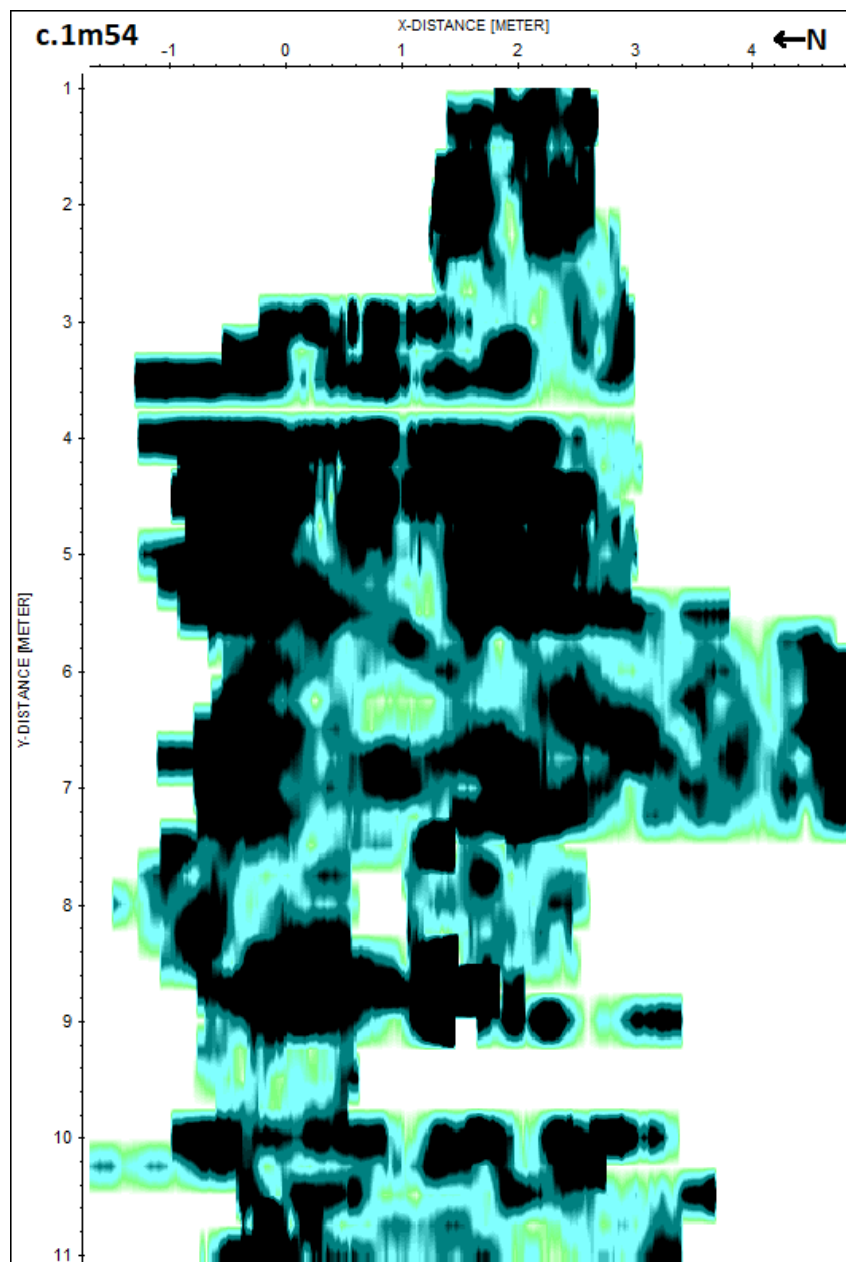
Figure 8: Time Slice at c. 1.54m Depth (250MHz, Area 1).

The other areas of strong signal visible in the time slice are much more irregular. They may represent the remnants of other graves, but there is no supporting evidence and it is difficult to be sure. In general, these appear as bands of signal which simply indicates the presence of a different material.

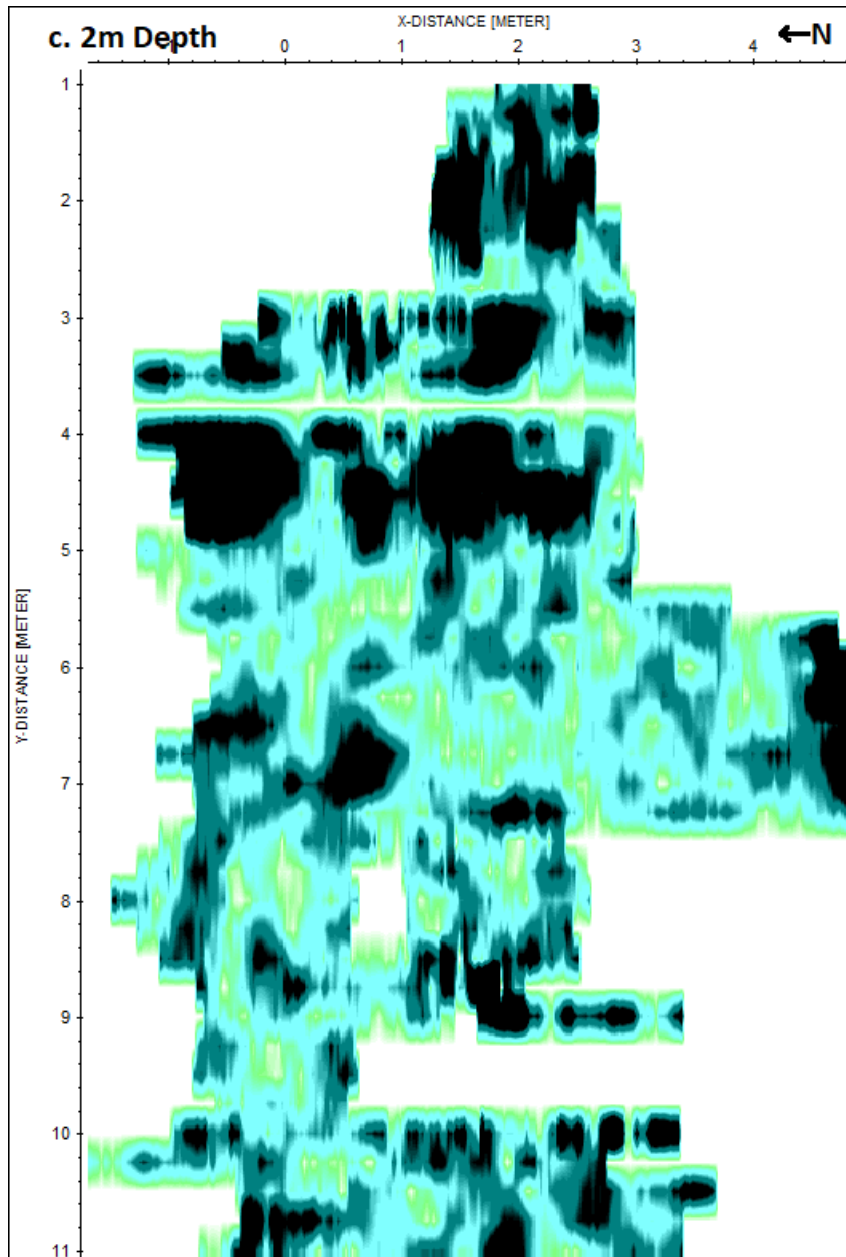
Figure 9: Time Slice at c. 2m Depth (250MHz, Area 1).

Beneath the level of the previous time slice there is no evidence of any new features. The only visible signals are echo effects from features 1 to 5 inclusive and feature 7 (cf Figures 9 and 10). An additional area, that marked “A” in Figure 10 becomes visible below the 2m depth. This appears in 2-dimensional data to be

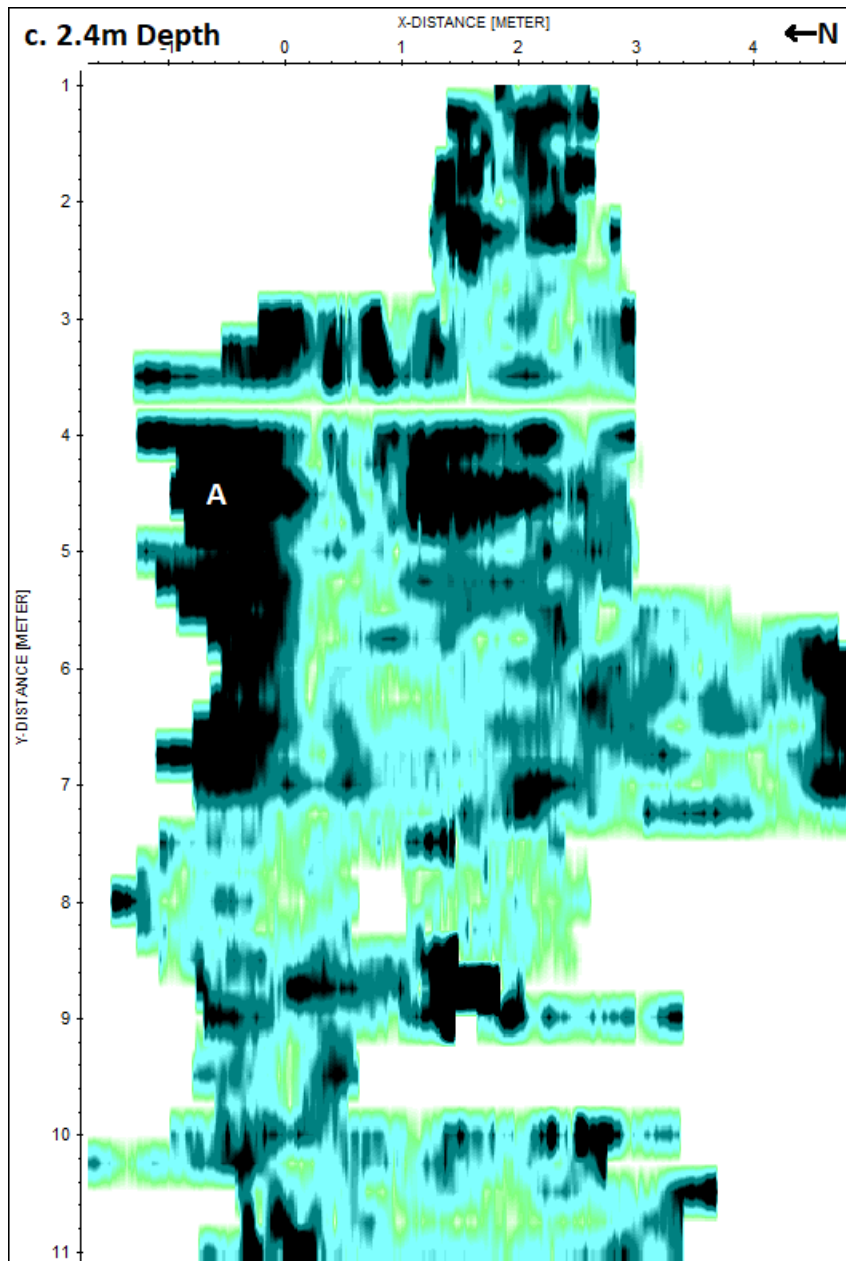
Figure 10: Time Slice at c. 2.4m Depth (250MHz, Area 1).

ringing from the shallow subsurface rather than a new feature and may indicate a more modern air gap (Figure 10). It also correlates, to some extent with the surface time slice (Figure 3). No new features appear below 48ns (c. 2.4m).

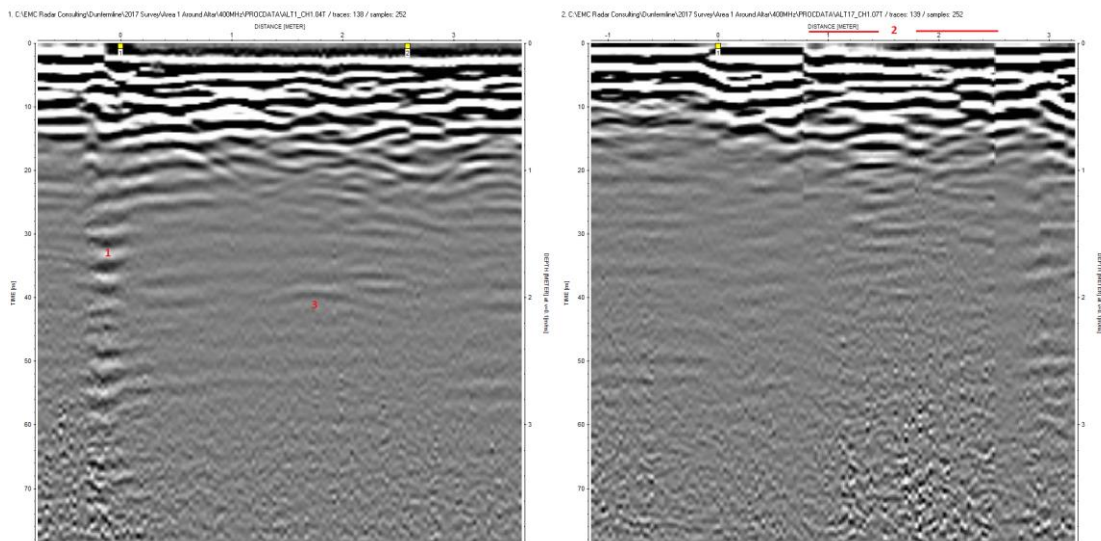
Figure 11: Survey lines 1 and 17 (400MHz, Area 1).

Survey lines 1 and 17 are reasonably representative of the area (Figure 11). The feature marked "1" in line 1 (left hand side of image) is ringing from a metal object at or near the surface, most probably the metal edge holding the carpet in place. The feature marked "2" in line 17 (right hand side of image) shows a discontinuity in the current church floor, covering an unknown feature. The only evidence of any deeper structure is seen in the relatively faint hyperbola at "3" in line 1 at a depth of 38ns (c. 1.9m in dry soil). In this context, potential grave information appears to be minimal, confirming the findings of the 250MHz survey. The feature numbers used in Figure 11 do not relate to those used in Figure 4 of the 250MHz survey.

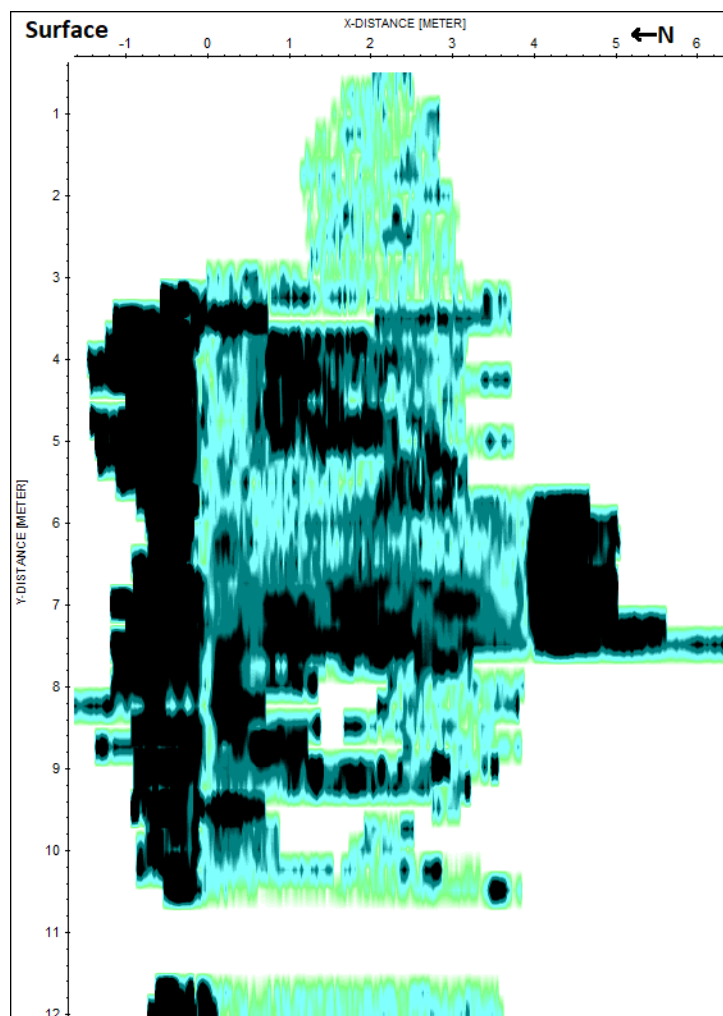
Figure 12: Time Slice extracted at the current floor surface for comparative purposes (400MHz, Area 1).

The surface time slice has been included in order to assist in identifying echo effects from this level potentially providing false data in the subsurface (Figure 12). As expected, it is similar to that from the 250MHz survey of the same area (Figure 3).

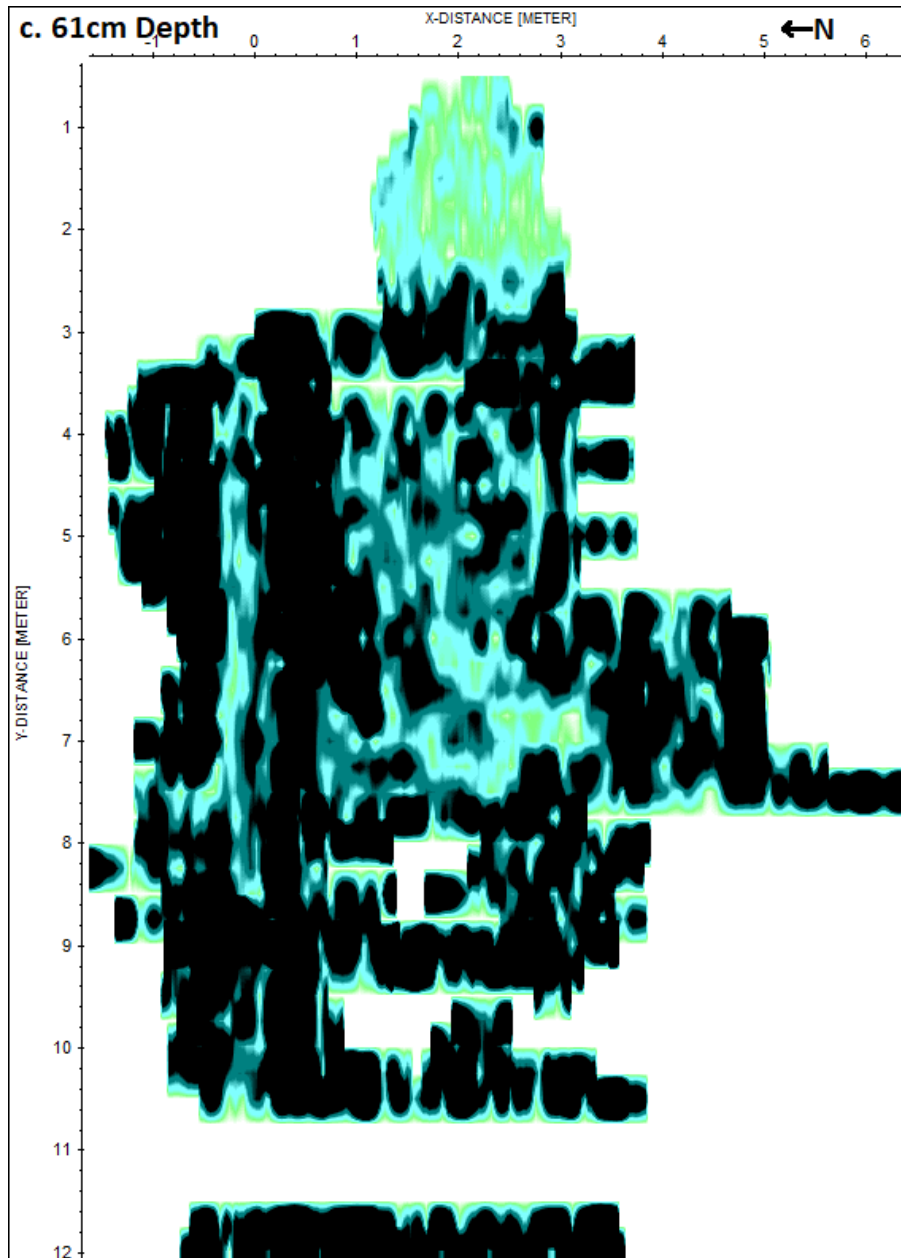
Figure 13: Time Slice at c. 61cm Depth (400MHz, Area 1).

As explained above, this depth measurement is understated assuming that the 55cm air gap is present uniformly across the area. Assuming this is the case, this depth could equate to 1.4m (55cm of air and 85cm of dry soil-type material).

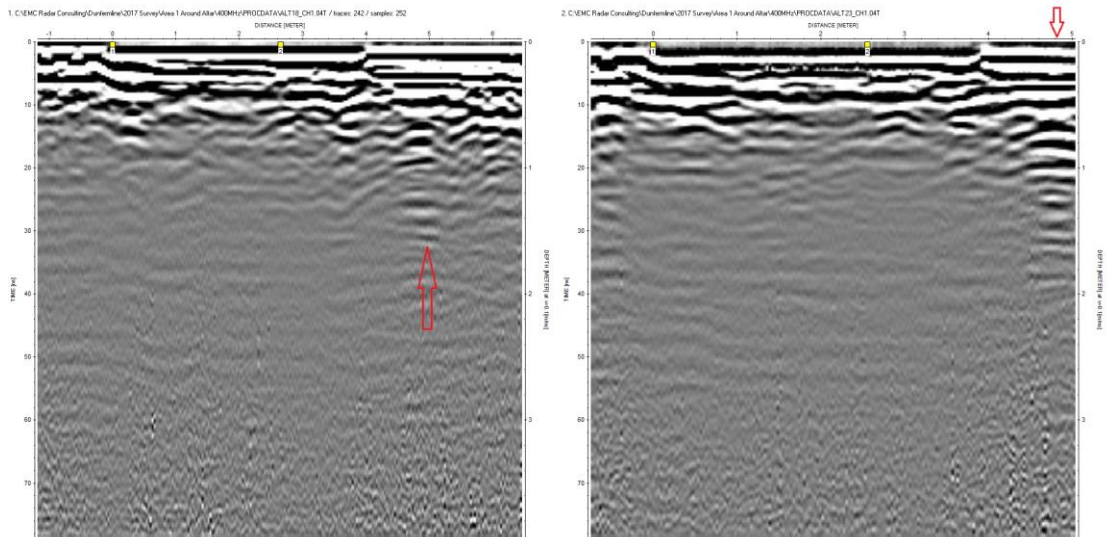
Figure 15: Survey lines 18 and 23 showing the cross section of Feature 7.

Figure 15 shows the clear delineation of another discontinuity, similar to feature 7, at current floor level at the start of survey line 23. Lying beneath the discontinuity a series of signals can be seen, the lower ones being echo effects of those above. This indicates the presence of another possible grave. Although the outline of the feature only measures 1.6m in length in Figure 14, it may continue westwards into the area which could not be surveyed due to church furniture.

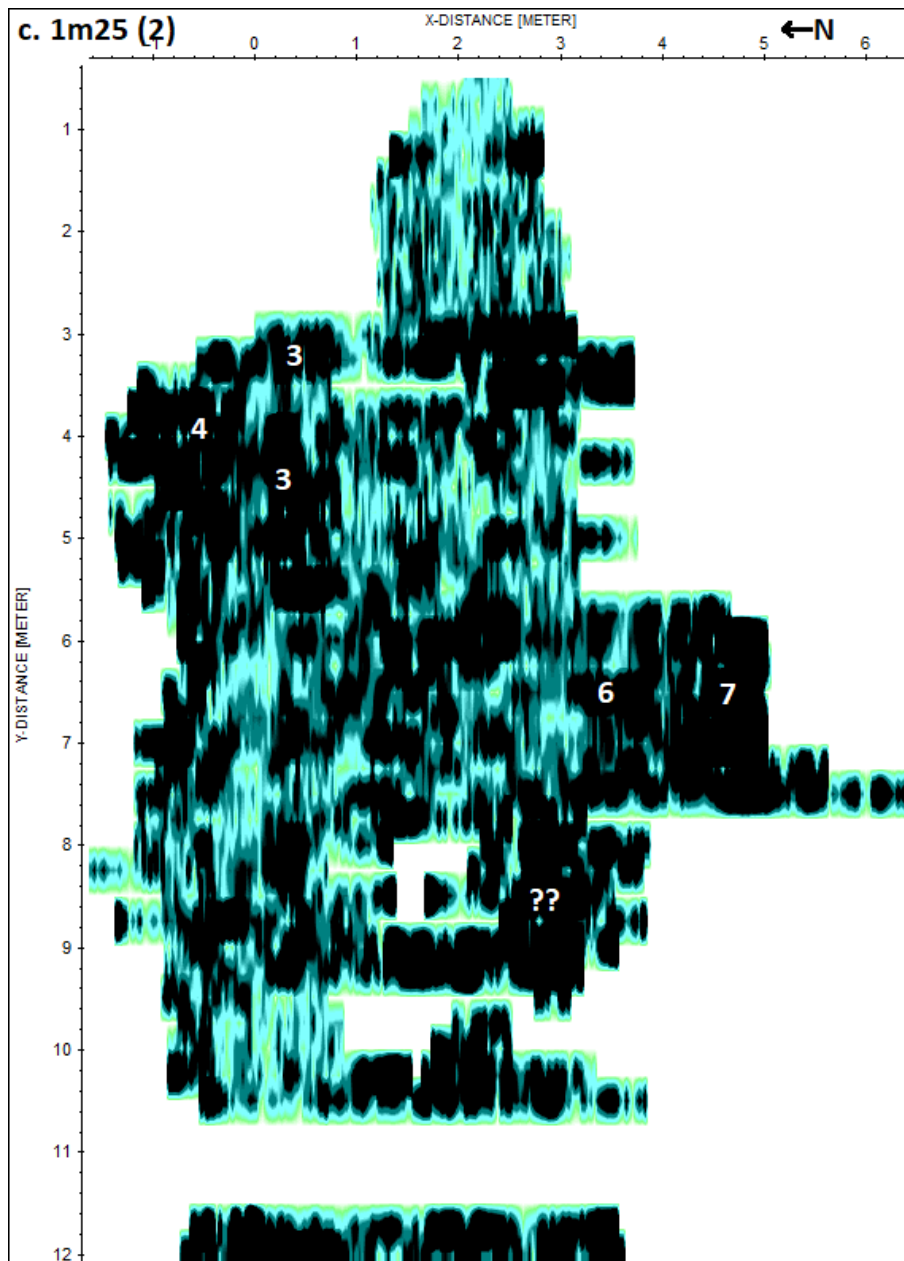
Figure 16: Time Slice from Figure 14 (c. 1.25m Depth) with added gain (400MHz, Area 1).

relative to the 250MHz. The amount of gain which has had to be applied to the respective data sets confirms that this is the case. Taking these factors into account, it appears likely that feature 6 is also a potential grave, as suggested by the 250MHz data.

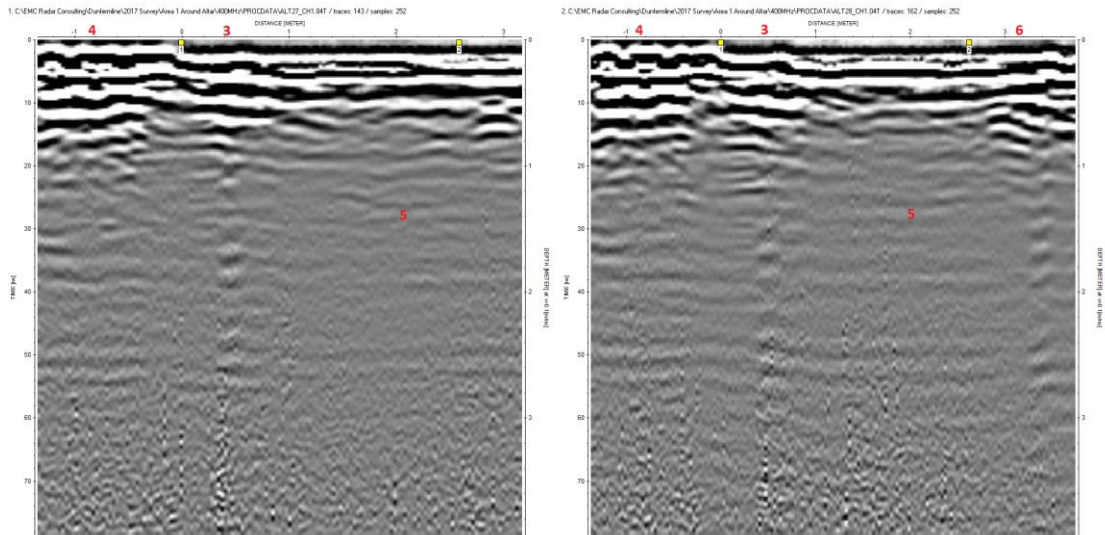
Figure 17: Survey lines 27 and 28 from the 400MHz data set showing cross sections of features 3 to 5 inclusive.

a number of layer-type signals with material concealed beneath them. This could indicate graves but could also be a different type of structure. Figure 5 is very much more ephemeral although its lower extent is visible and does not appear to be an echo effect. (Echo signals usually follow the same shape as the original signals which they repeat.) On the right-hand side of survey line 28, there appears to be another potential grave, marked “6” (Figure 17). This survey line lies along $y = 4.75\text{m}$ in the time slice. In this location it cannot be feature 6 although it does align with it. Most of the feature lies beneath the pews.

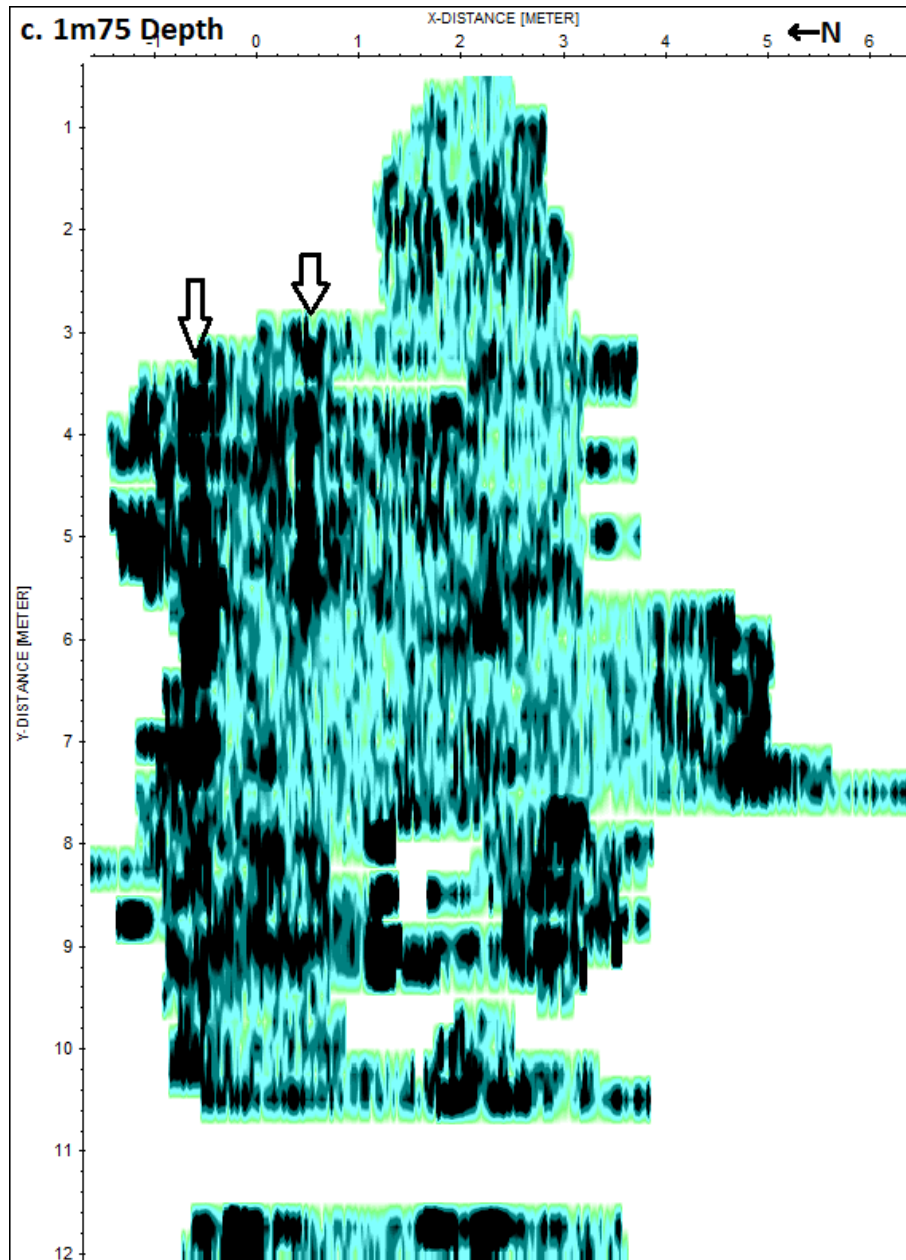
Figure 18: Time Slice at 1.75m Depth (400MHz, Area 1).

This presents again the problem of attenuation (or loss) of the 400MHz signals, confirming the relatively unsuitable soil in the subsurface within survey area 1.

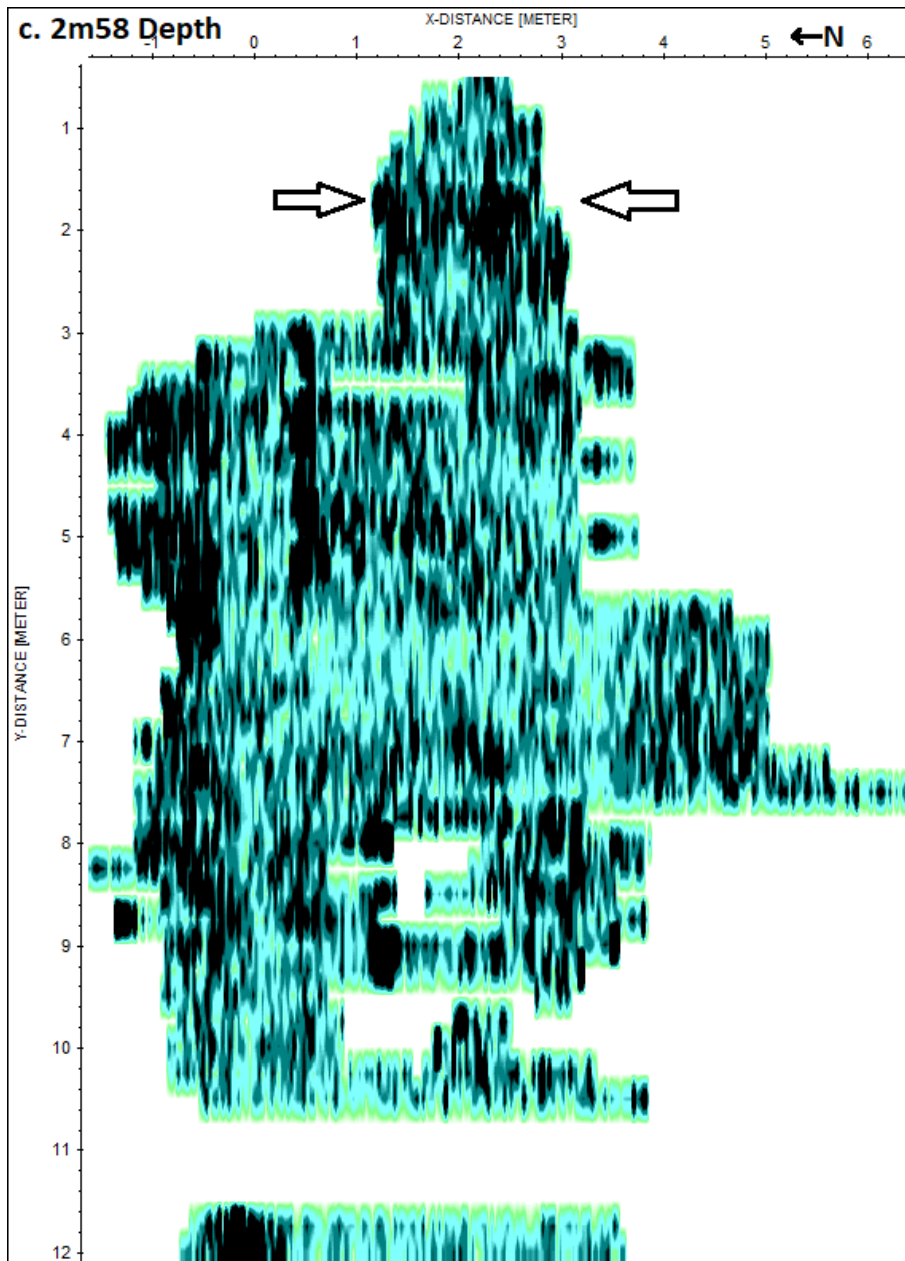
Figure 19: Time Slice extracted at 2.58m Depth (400MHz, Area 1).

This time slice is similar to the previous one (which may be due to echo effects rather than continuity of structures). There is one additional North/South line at the eastern end of the survey area, marked with arrows in Figure 19. It is unfortunately not possible to check this line in vertical section due to the superimposition of wi-fi

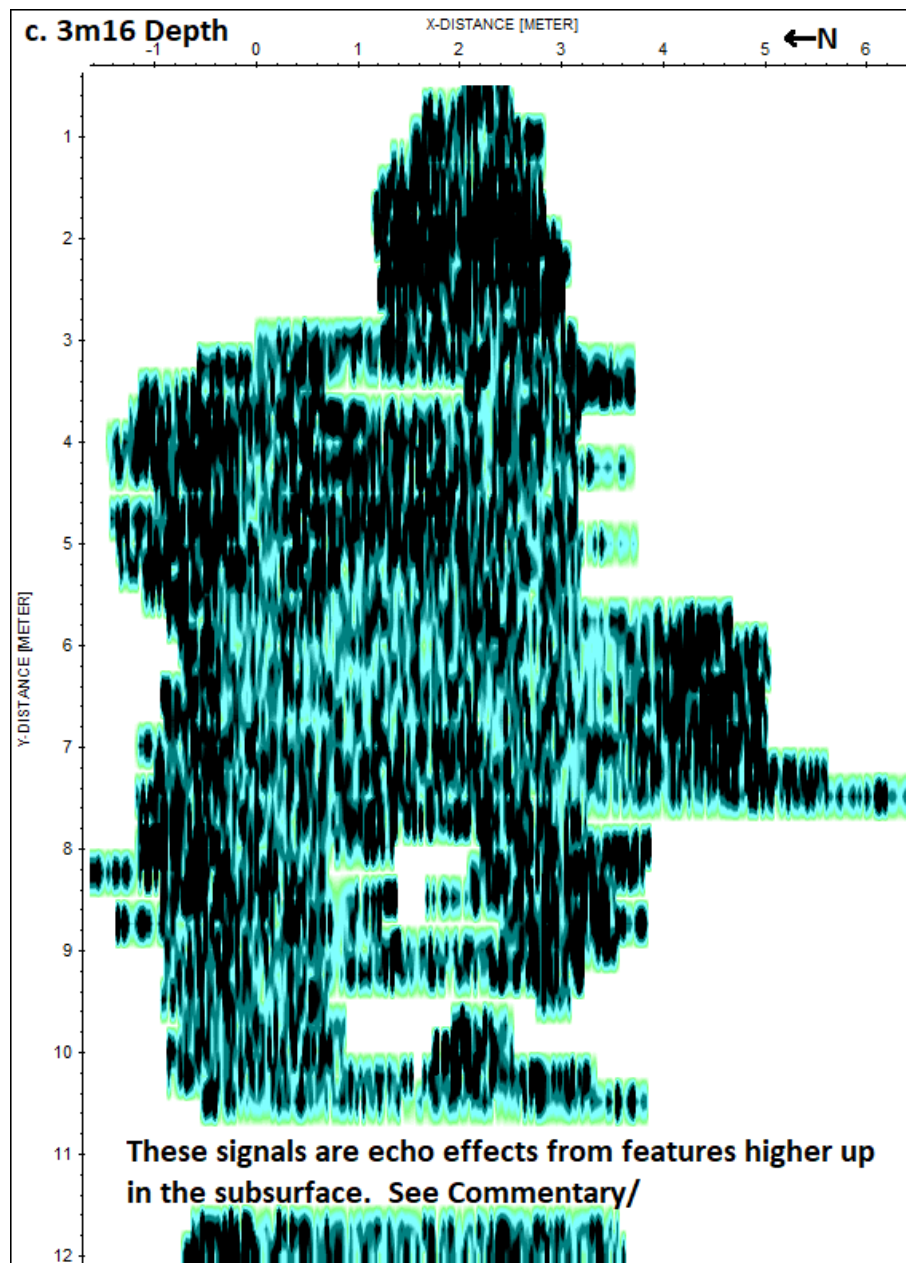
Figure 20: Time Slice showing combined echo effects (400MHz, Area 1).

Below the level of the previous time slice almost all signals appear to be echo effects, coupled with the wi-fi signals from the Abbey's alarm signals. At a number of levels, notably c. 60ns (not illustrated) and c. 63ns (Figure 20), these echo effects reflect the features described above but also indicate the presence of features 1 and 2 in a manner consistent with the data from the 250MHz data set. There is clearly some sort of feature here, but it is not possible to determine what these represent non-intrusively.

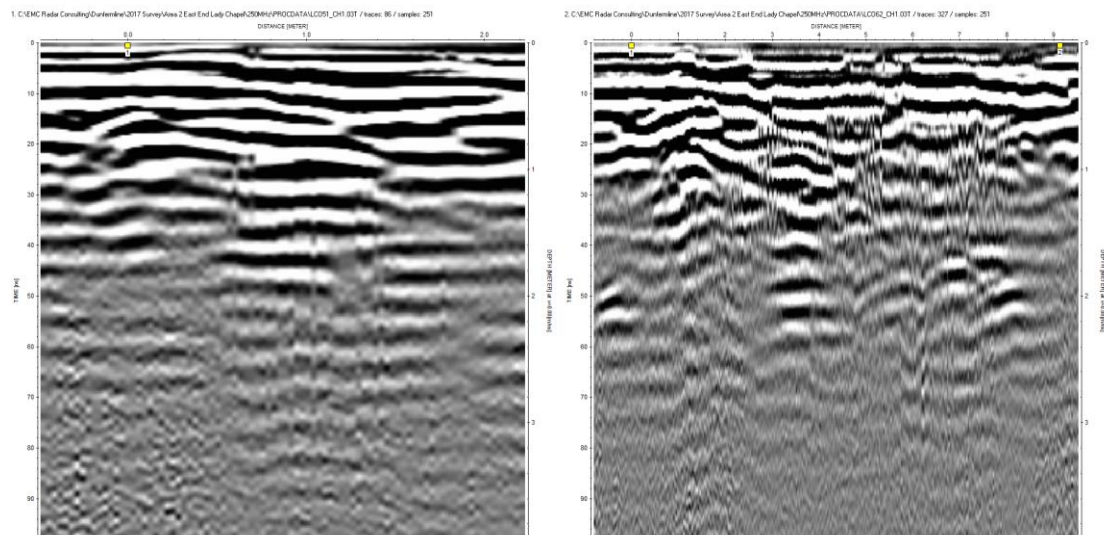
Figure 21: Survey Lines 51 and 62 showing large features in the subsurface at different depths (250MHz, Area 2).

Many of the survey lines show large targets within these depths. Consecutive lines show clearly the continuity of features from one to the next indicating the probable presence of at least one former wall. Survey lines 51, 62, 66 and 72 are good examples (Figures 21 and 22).

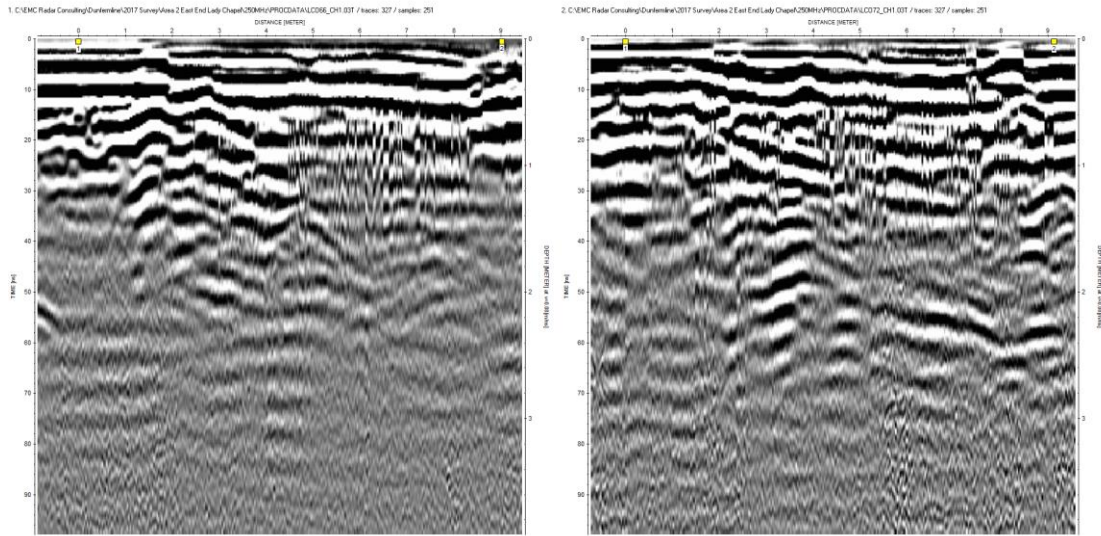
Figure 22: Survey lines 66 and 72 showing a variety of archaeological features (250MHz, Area 2).

two survey lines. Survey line 66, 1m to the East of line 62 has a very large feature within it and also some evidence of a line leading towards the NE wall of the current church (Figure 22). Line 72, 1.5m to the East of line 66, has a completely different array of features including what could be the stump of a wall foundation and a layer change leading from its base towards the NE wall of the current church.

Feature 4 is similar in nature to the first feature. Two cross sections can be seen in lines 66 and 72 (Figure 22). The signals resemble constructional material and they underlie the previously observed probable wall and are situated above a lower column of signal which may also represent constructional material. They do not appear to be undamaged. It is more likely that they represent the ruined remains of an earlier structure. The broad V shaped feature in the NW corner is very similar in nature. A vertical section from this area can be seen in survey line 60 (Figure 24).

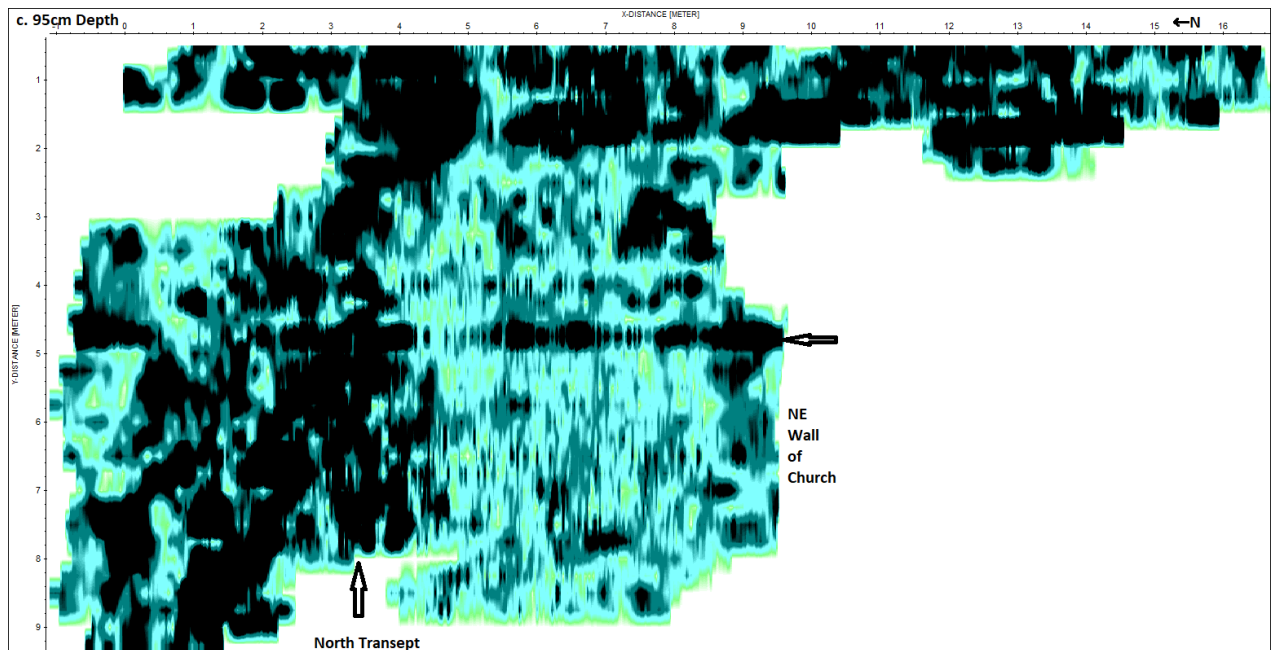
Figure 23: Time Slice extracted at c. 95cm Depth (250MHz, Area 2)

The first patterning that moves beyond distinguishing the path and areas of damp ground shows a thin rectangular feature in the angle between the East wall of the North Transept and the NE wall of the church. This is marked by arrows in Figure 23. The North/South line leading towards the NE wall of the church can be seen in survey line 72, Figure 22. It forms the bottom layer of the near subsurface and is credible as being the remains of a former construction directly underlying the present ground surface. The anomalies forming the more substantial East/West line of the feature appear in vertical section to be consistent with the remains of a wall of Figure 24 at $x = 3.5\text{m}$.

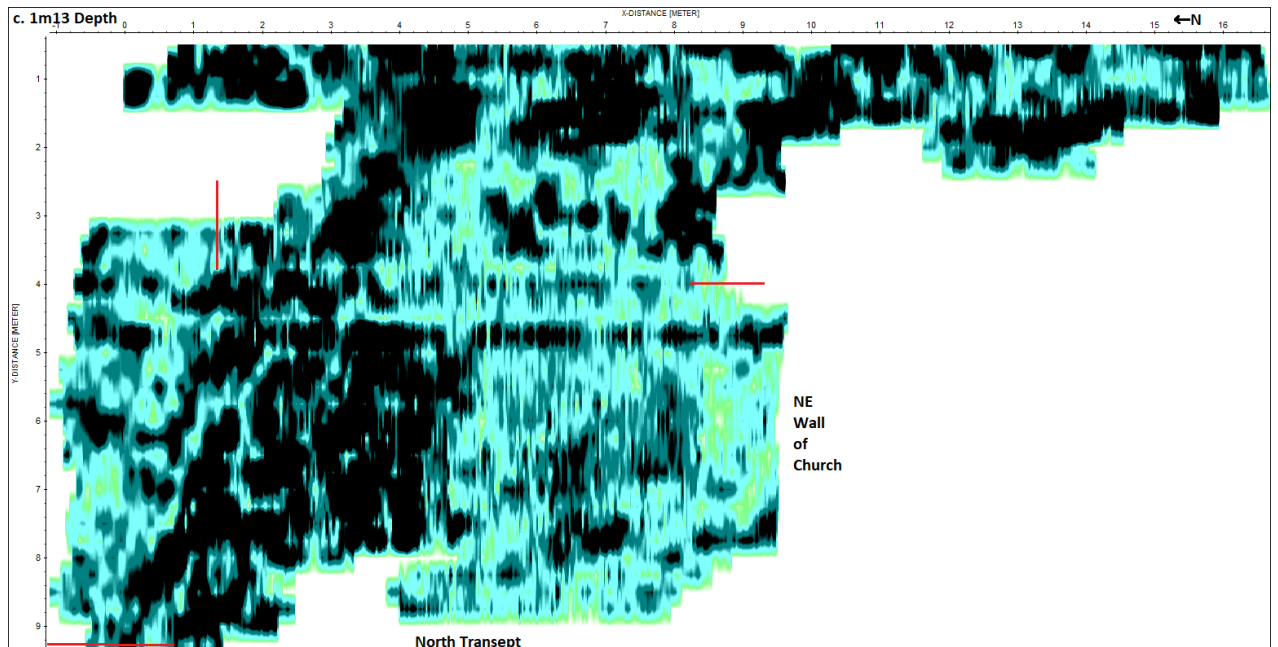
Figure 25: Time Slice extracted at c. 1.13m Depth (250MHz, Area 2).

Figure 25 also demonstrates that there is another large block of former construction adjacent to the original rectangular feature on its North side. The East and West corners of this feature are marked by red lines in Figure 25. It is not clear what the relationship is between these two features, a situation which is complicated by the fact that this second linear feature underlies the modern path. Several survey lines, including 60 and 75 (Figures 24 and 26), do not show any gap between them although only the original line continues below 40ns (c.1.6m) in the subsurface.

However, the possibility of the area of the Lady Chapel being defined by the badly degraded wall to the East of the 2 parallel lines originally observed seems now to be very likely (cf Figure 25). The larger rectangular area, thus formed by the two

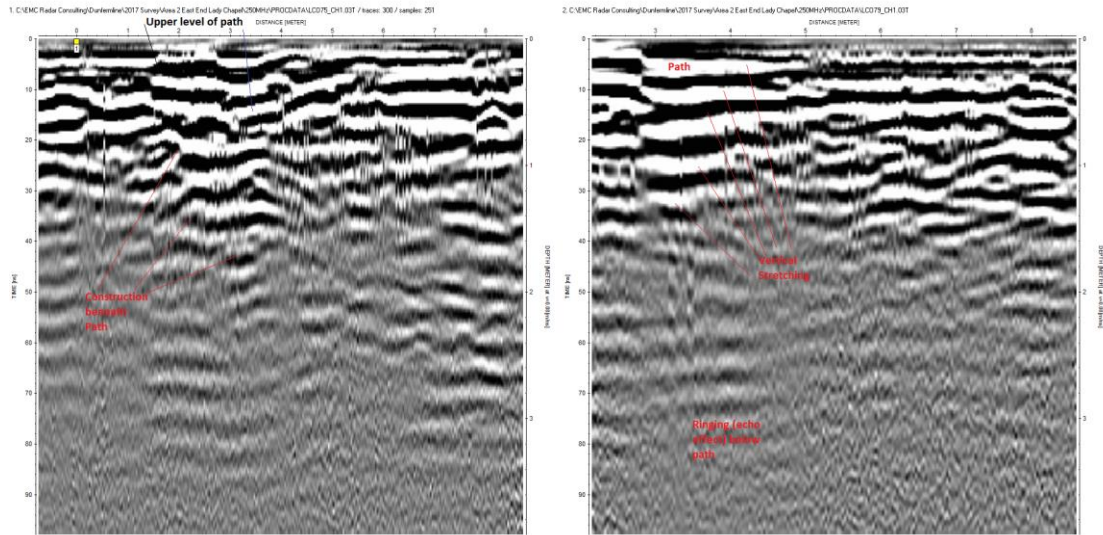
Figure 26: Survey lines 75 and 79 showing former construction (lhs) and relatively modern features (rhs) [250MHz, Area 2].

Beyond the North/South boundary the dark areas in the time slice appear to be relatively modern infill and are probably showing as anomalous from additional moisture content. When black and white lines in the data stretch in the vertical direction this can mean that the signals are slowing down which is one indicator of the presence of moisture. The prevalence of ringing lower down suggests an increase in attenuation (loss of signal) in the soil below which is another potential effect of added moisture. Both of these phenomena are visible in survey line 79 (Figure 26 rhs)

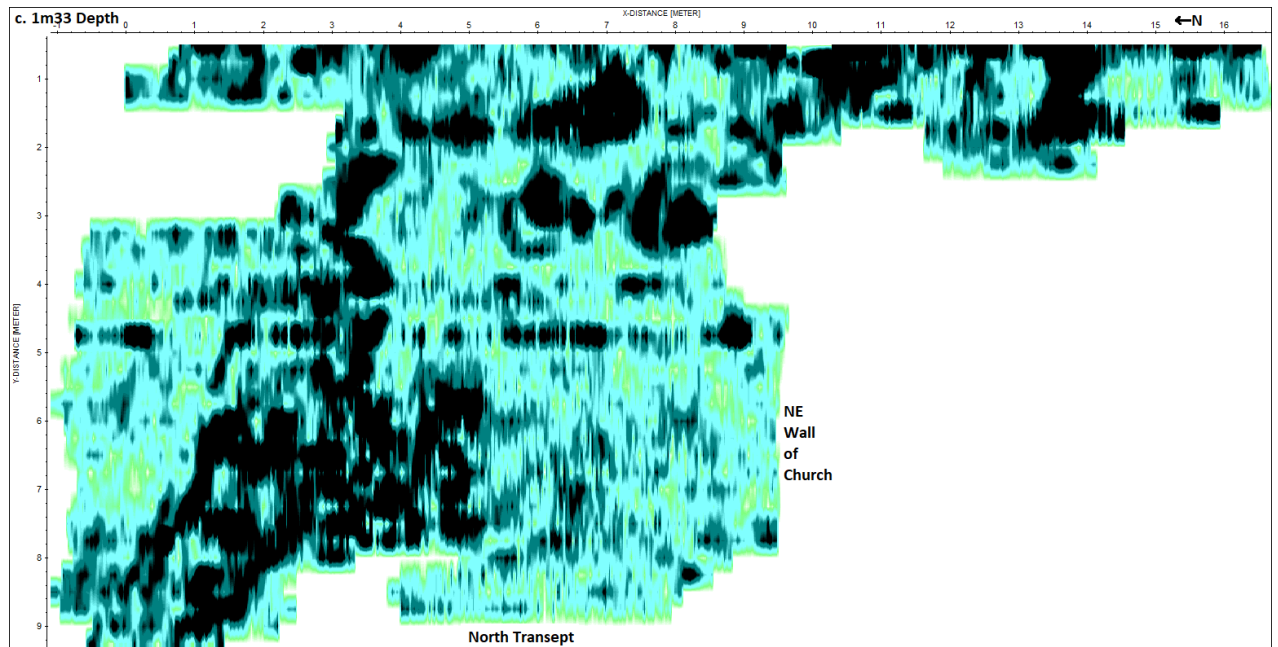
Figure 27: Time Slice extracted at c. 1.33m Depth (250MHz, Area 2).

The same features are visible at this depth as were visible in the previous two time slices (Figure 27). The image is clearer due to the disappearance of many of the shallower, more randomly spaced anomalies.

From the irregular shaping, the majority of other anomalous areas are likely to represent pockets of additional moisture. There is nothing indicating an irregular void within a square or rectangular outline such as might be expected for a grave.
