Ground Penetrating Radar Survey

the Central Area between the Vestry and the Altar

2 External Areas overlying the former Lady Chapel

Dunfermline Abbey

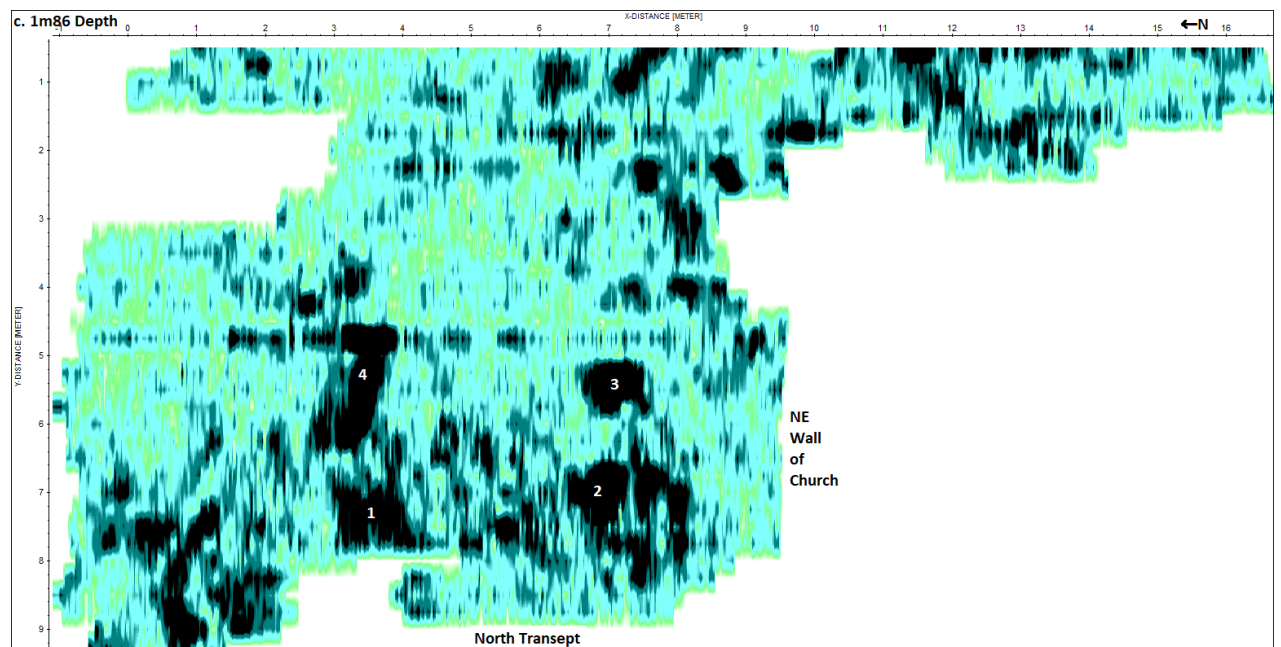
Figure 28: Time Slice extracted at c. 1.86m Depth (250MHz, Area 2).

Below 40ns the larger features disappear (Figure 28). Four main features remain within the area of the rectangular feature previously described. The first of these lies beneath the possible wall described earlier. It appears to be the upper layer of a feature whose base lies on a possible floor (evidenced by a layer change). Line 60 in Figure 24 illustrates this in vertical section. The lower column of signal is likely to represent a column of construction material. It is clearly different (narrower) than what lies above and is separated from it by a possible curved cap. It is not clear what this represents although drainage is a possibility.

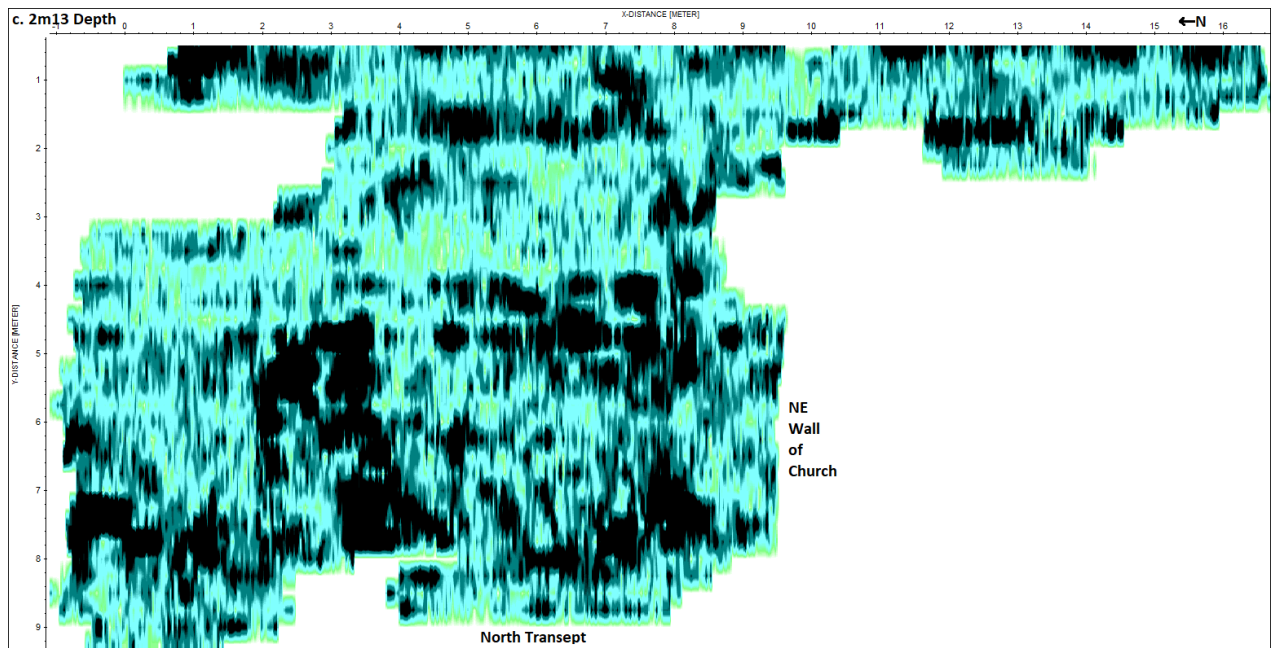
Figure 29: Time Slice extracted at 2.13m Depth (250MHz, Area 2).

The lower columns of signal resolve quite clearly at this depth into a simpler rectangular feature which follows the lines of the probable walls initially detected higher up.

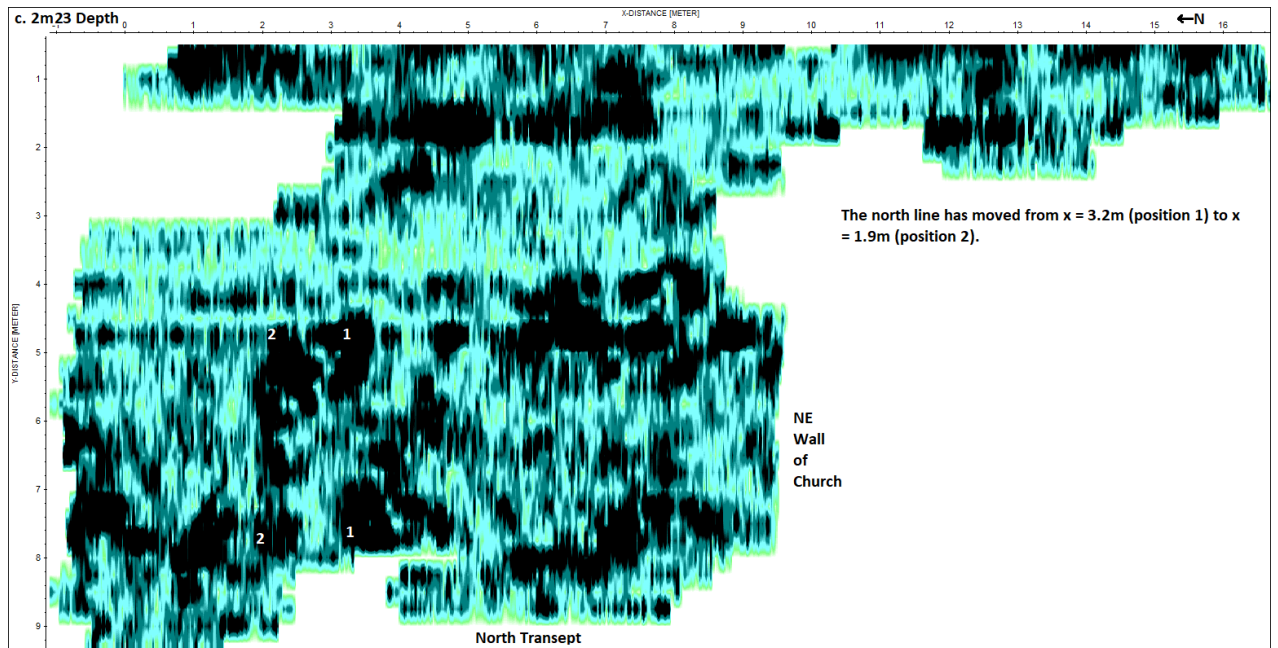
Figure 30: Time Slice extracted at 2.23m Depth (250MHz, Area 2).

The same group of features is visible at this depth, but the size of the rectangle formed by/around them has increased (Figure 30). The North/South boundary wall, visible

along $y = 4.75\text{m}$ and 4m is unchanged from its initial position in Figure 23. The intermittent signals which might continue these lines northwards are not substantiated by the 2-dimensional data and are mostly echo effects from moisture above. However, the East/West line marking the northern boundary has moved from $x = 3.2\text{m}$ northwards to $x = 1.9\text{m}$ (2 in Figure 30). The vertical view of the data confirms the likely presence of structural material.

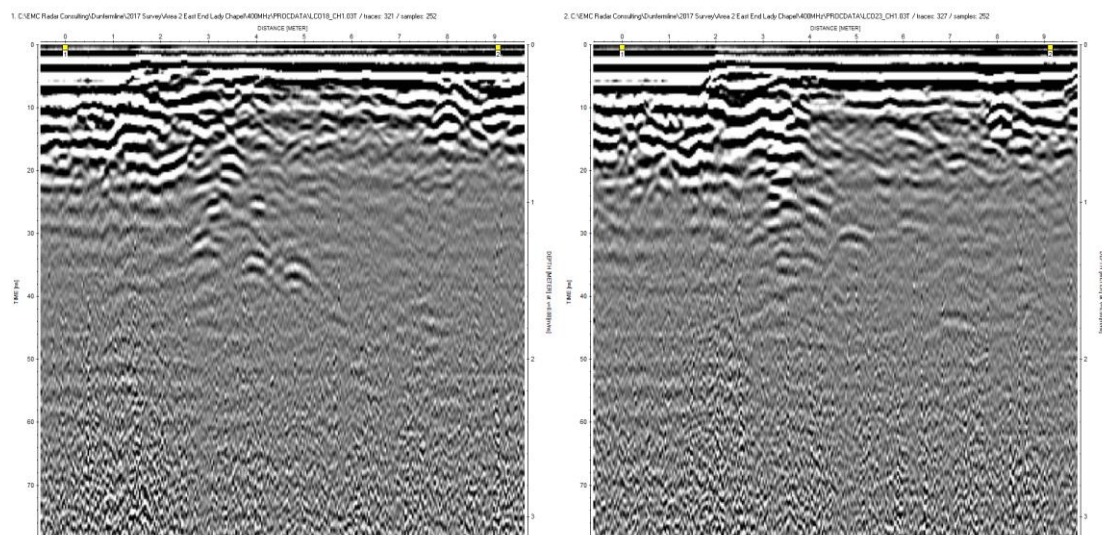
Figure 31: Survey Lines 18 and 23 (400MHz, Area 2).

The 400MHz data is characterised by a band of crowded signals in the shallow subsurface, a range of discrete hyperbolas below 15ns (c.60cm) depth and fewer deeper hyperbolas below 40ns (c.1.6m). There is also much more evidence of the effect of the transmissions from the fire security system, particularly below 40ns than is found in the lower frequency data set. As expected target definition is less diffuse and probing depth is also less than that achieved by the 250MHz antenna. Lines 18 and 23 are reasonably representative (Figure 31).

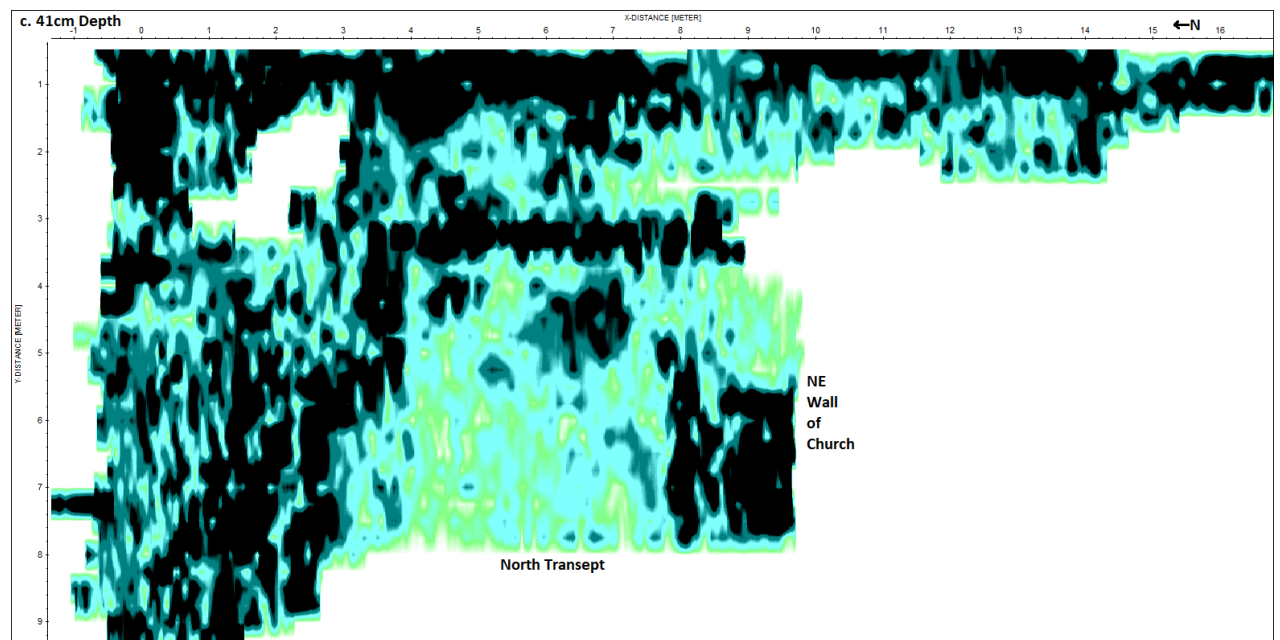
Figure 32: Time Slice extracted at c. 41cm Depth (400MHz, Area 2).

To the North of this possible grave there is a linear feature which may be associated. Examination of the vertical section reveals a short column of signal, apparently undamaged, consistent with a small wall of c. 0.5m in height. It is not possible to provide dating evidence for this. The fact that this feature does not appear in the 250MHz data suggests that either its size is too small or its proximity to the grave too small.

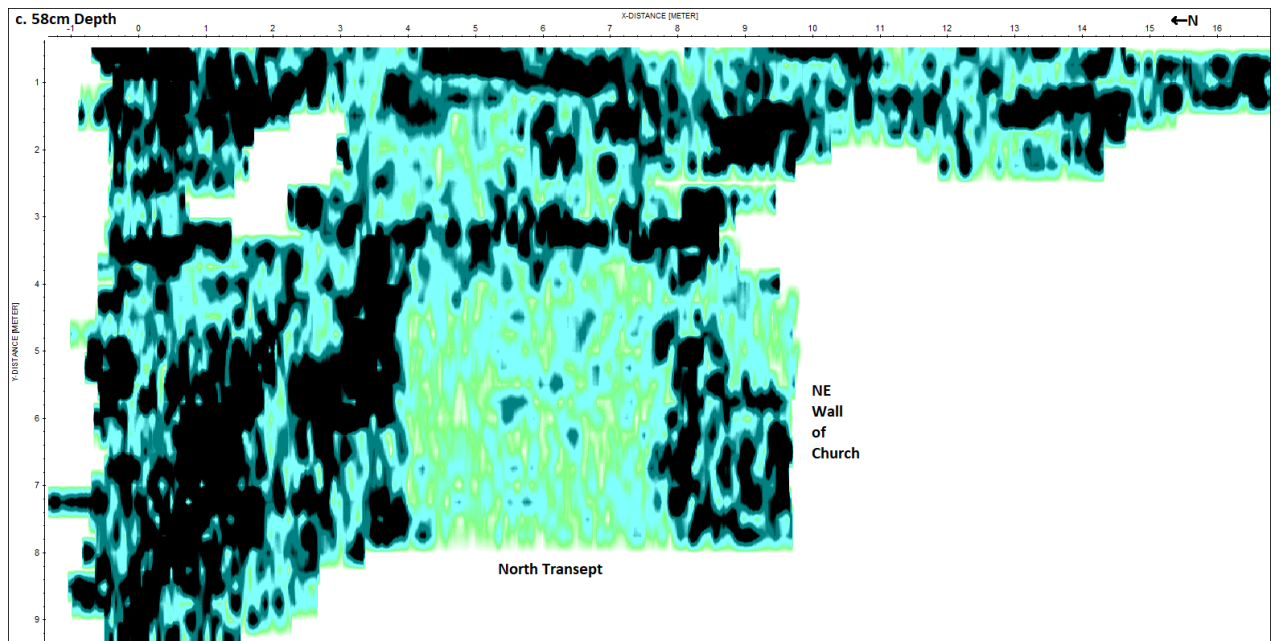
Figure 33: Time Slice extracted at c. 58cm Depth (400MHz, Area 2).

There is a large irregular area of anomalous material to the North of this area. Viewed in vertical section this appears to be made up from double signal columns

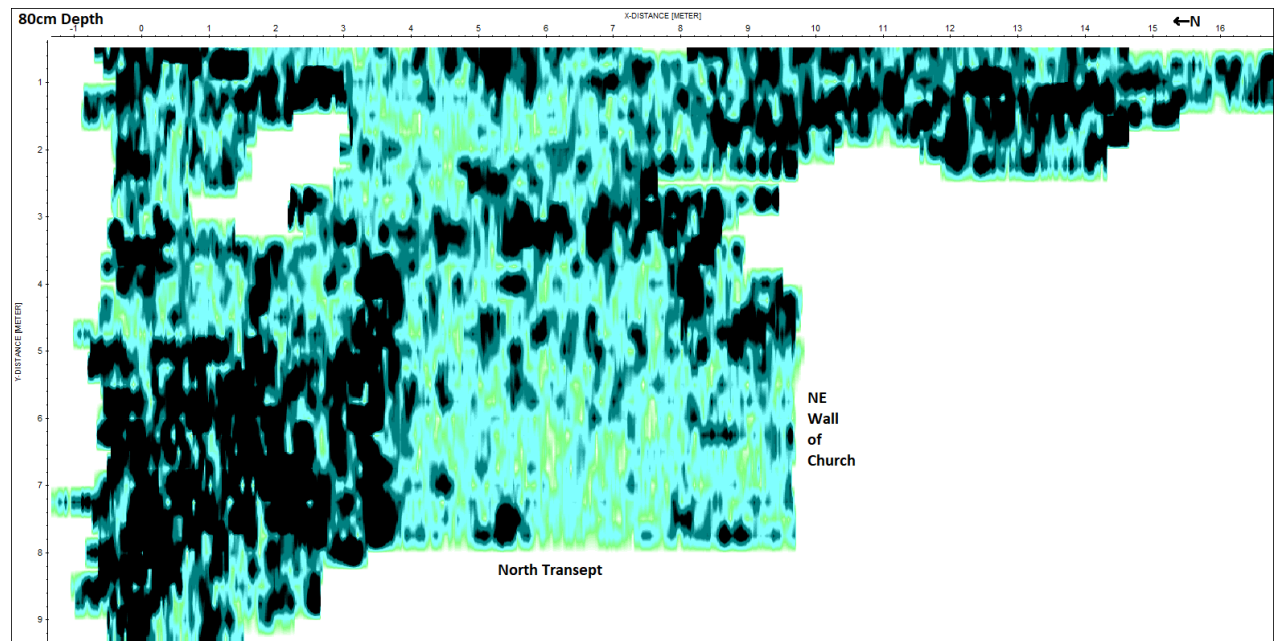
Figure 35: Time Slice extracted at 80cm Depth (400MHz, Area 2).

By 80cm depth the grave in the corner and most of the shallow wall have disappeared to be replaced by a new perimeter. The overall appearance of the northern and eastern boundaries is closer in appearance to the 250MHz data. The area to the North of the main features is full of strong signals but there is no discernible interpretable pattern.

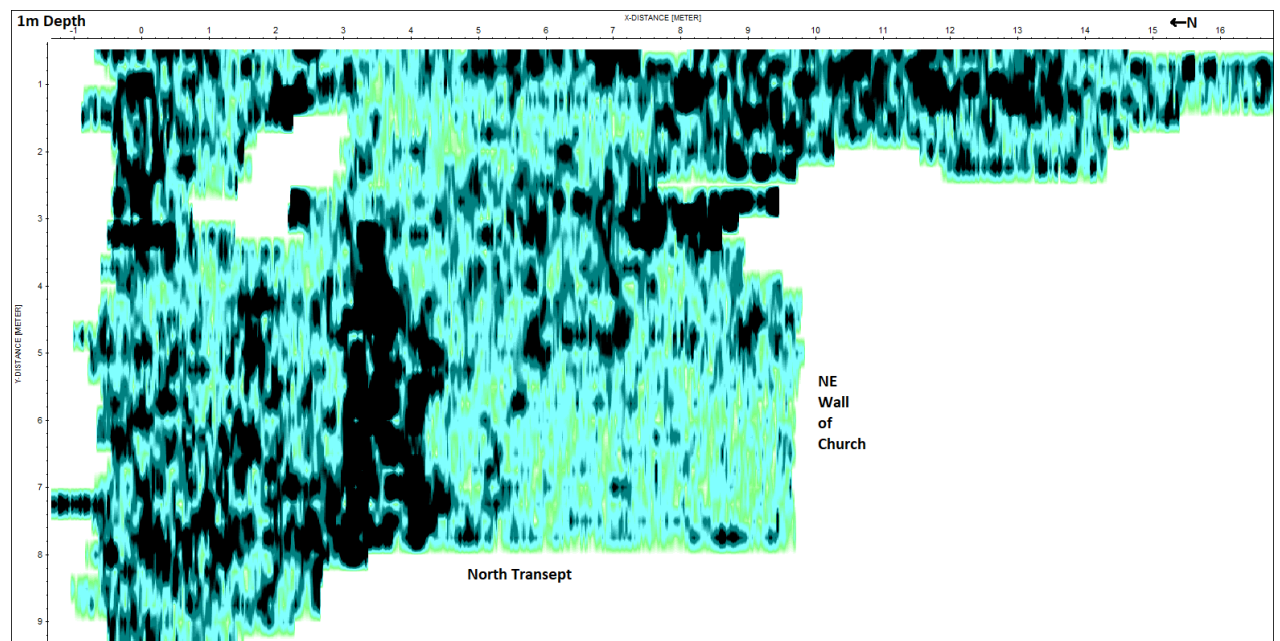
Figure 36: Time Slice extracted at 1m Depth (400MHz, Area 2).

At the eastern end of the principal area of interest and approximately in the middle of the eastern boundary there is a faint trapezium shaped outline. The size is approximately 2m length by 1.1m width which could potentially represent the perimeter of an adult grave. It is not possible to confirm or reject this proposition from the vertical section. All of the reflectors are small and only one found to be hyperbolic in shape (implying a smooth, undamaged surface).

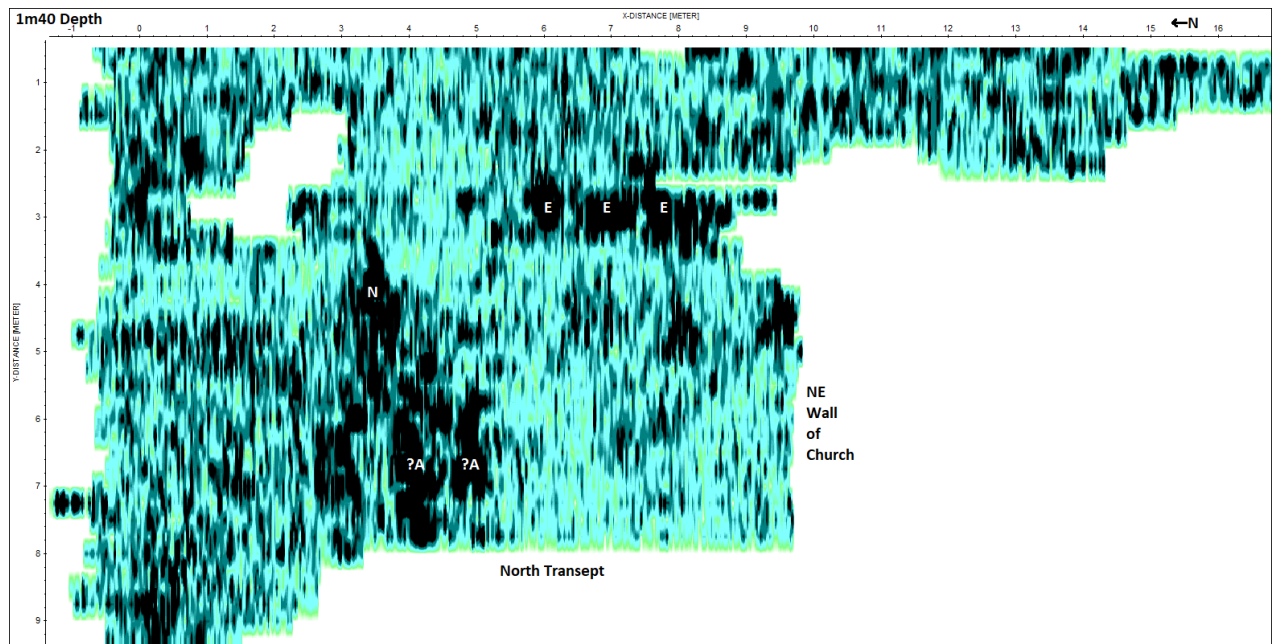
Figure 38: Time Slice extracted at 1.4m Depth (400MHz, Area 2).

The speckling on this time slice can safely be ignored as it is interference and not reflections from the subsurface (Figure 38). The line of anomalies marked E is the formerly observed eastern boundary, presumably to the former Lady Chapel. The identification of these strong signals with masonry is probable because the feature becomes more extensive with depth as would be expected for the partial remains of a

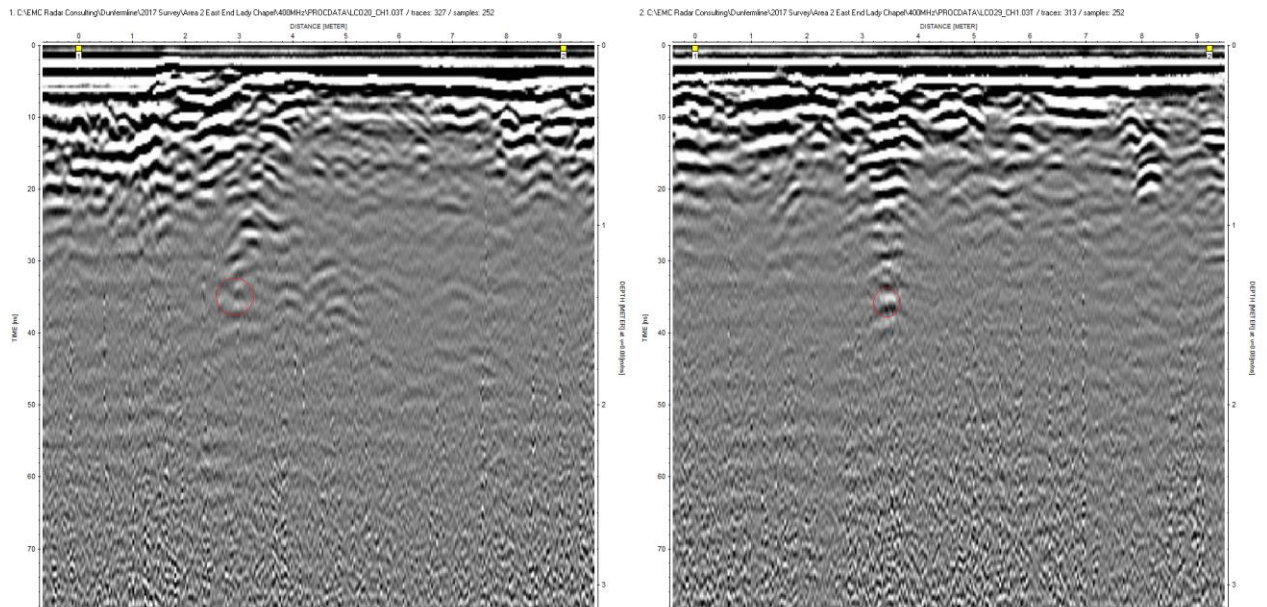
Figure 39: Survey lines 20 (lhs) and 29 (rhs) [400MHz, Area 2]

The feature marked N lies along the line of the northern boundary as can be seen in survey line 29 (Figure 39, rhs). From the 2-d data, this may not be the wall itself although it is associated with it. The feature has been degraded at some point in the past from the truncated nature of the signals.

From the 2-dimensional data, there are real signals potentially as low as 50ns although these are few and very faint. It is impossible to examine these in time slice a) because of the interference (cf Figure 39) and b) because the soil is not entirely suited to GPR survey and there is a lot of ringing lower down in the data. These two effects combine to obscure the real features below 1.4m. It should be noted that, although the soil is not entirely suited to GPR survey, this is insufficient to prevent the survey being useful and there is a stark contrast, for example, between the quality of the results in Area 2 in comparison with Area 1. This is likely to be due to the way in which the floor of the current church has been constructed.

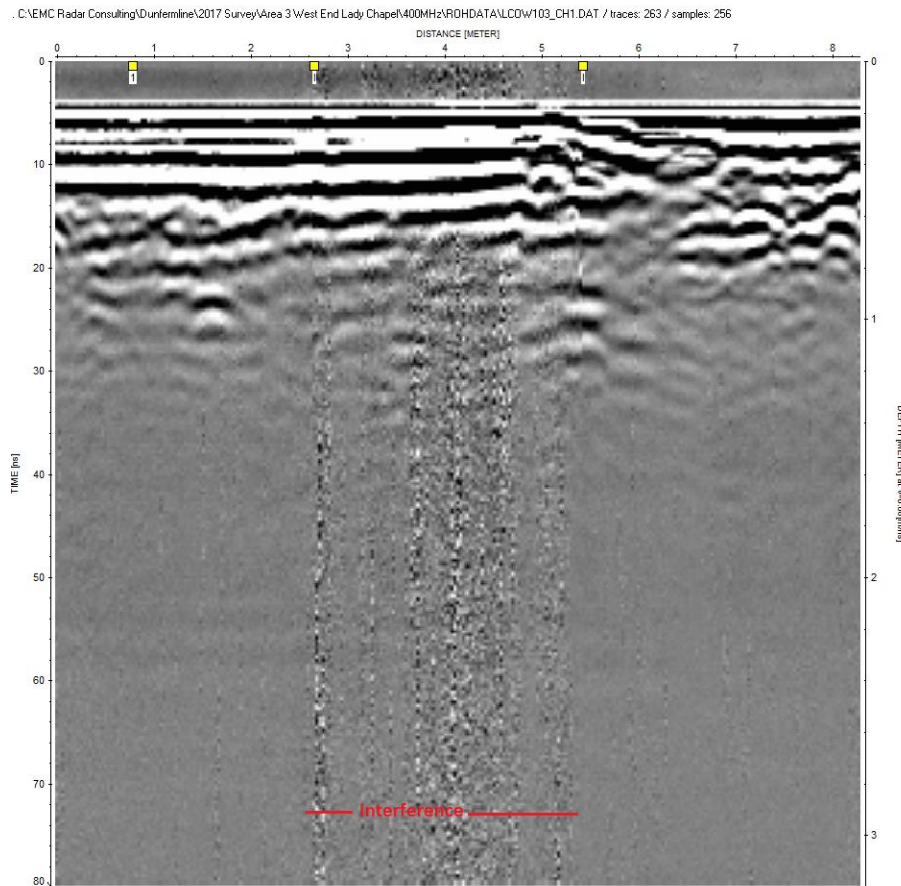
Band of external interference showing on raw GPR data.
