# Impacts of Hurricane Mathew on adjacent developed and undeveloped barrier islands in southeastern North Carolina

Regional Studies in Marine Science

Volume 53, June 2022, #102391

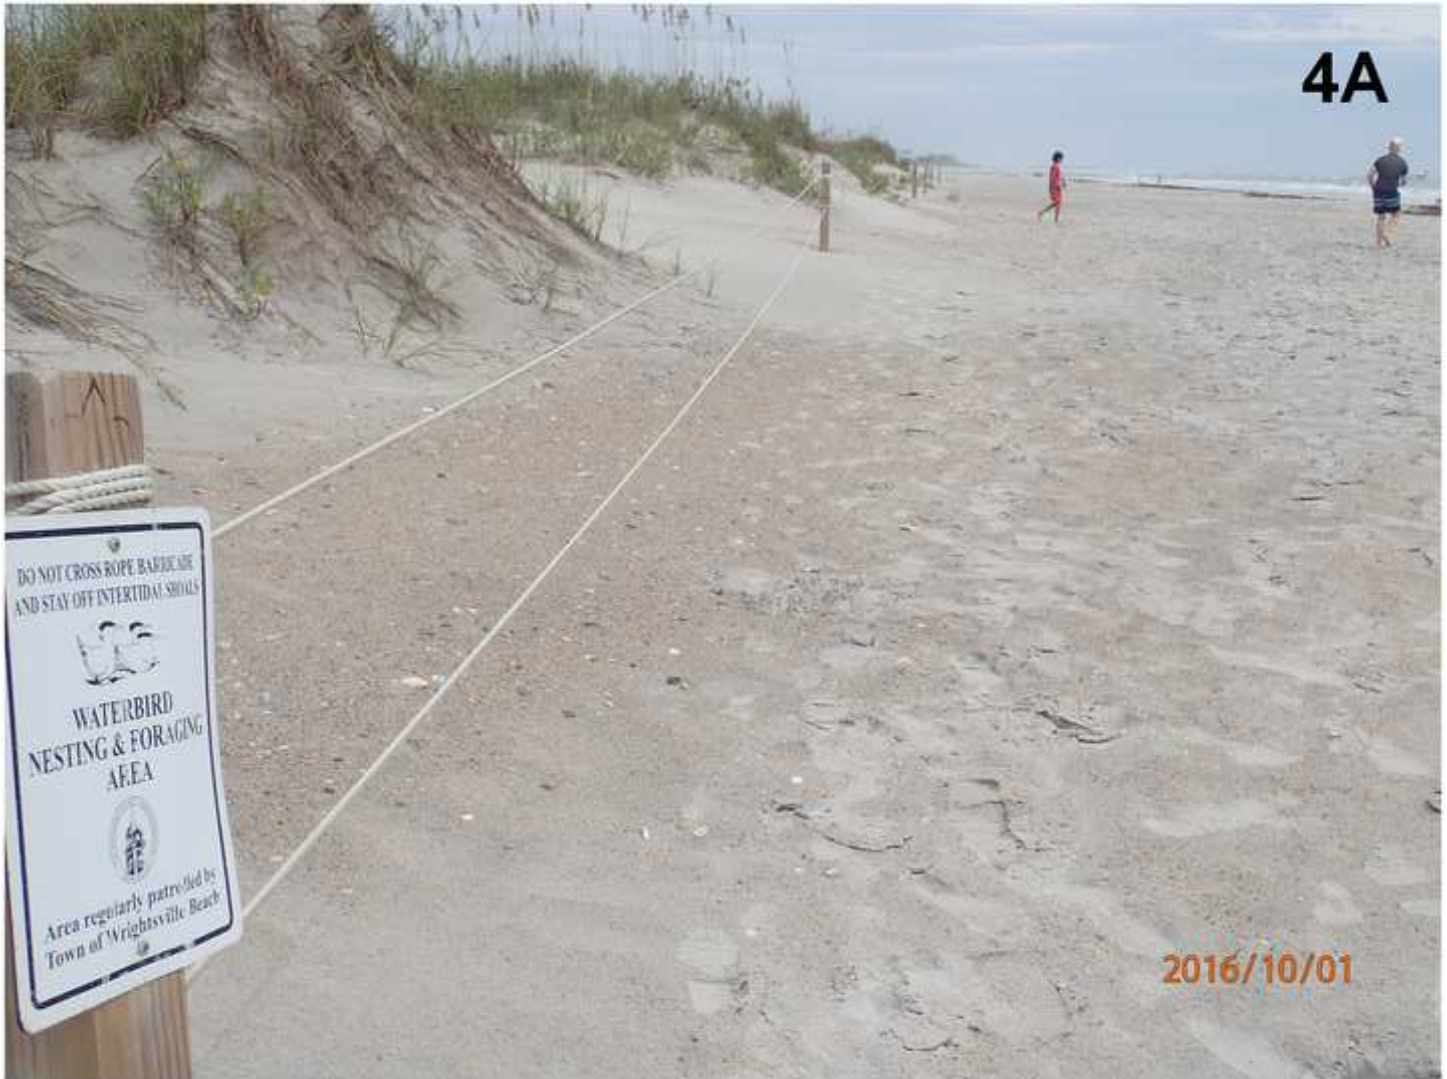
4A

5  
6  
7  
8  
9 243 WB01 comprises the old location of Mason Inlet, situated within a defined Inlet Hazard Area. At the  
10  
11 244 time of the pre-storm survey visit, the forebeach was wide and relatively flat, backed by a

12  
13  
14 245 discontinuous and low elevation frontal dune ridge with moderate to low vegetation cover (Figure

15  
16 246 4A). A post-storm site visit on October 13<sup>th</sup> showed that storm-induced surge only reached as far as

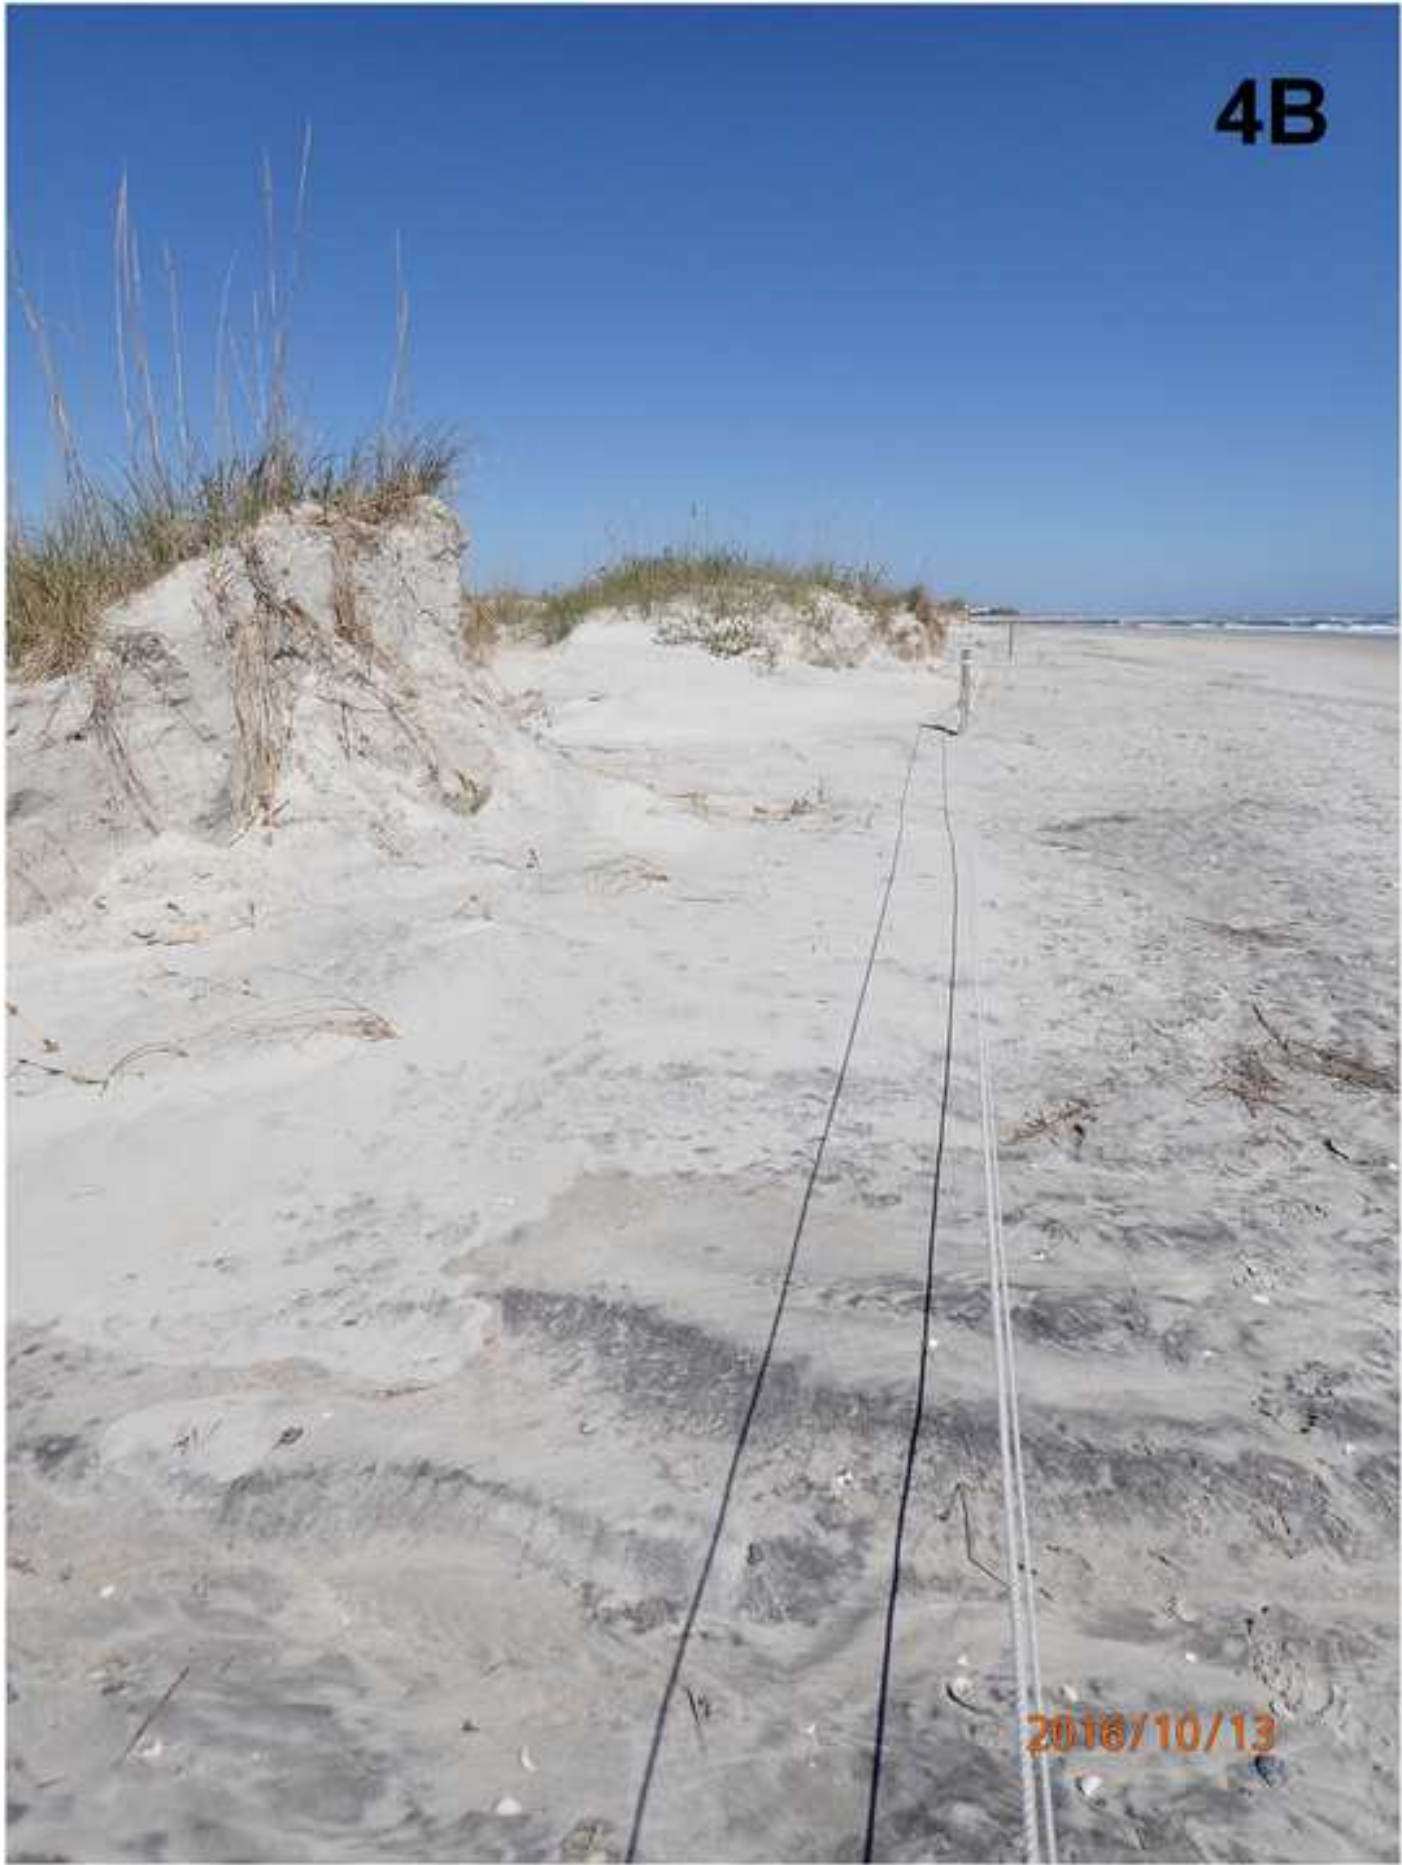
4B

17  
18  
19 247 the base of the frontal dunes, resulting in minor erosion and scarping, coupled with vegetation loss

20  
21 248 and/or burial from sediment deposition (Figure 4B). There was no evidence of dune breaching,

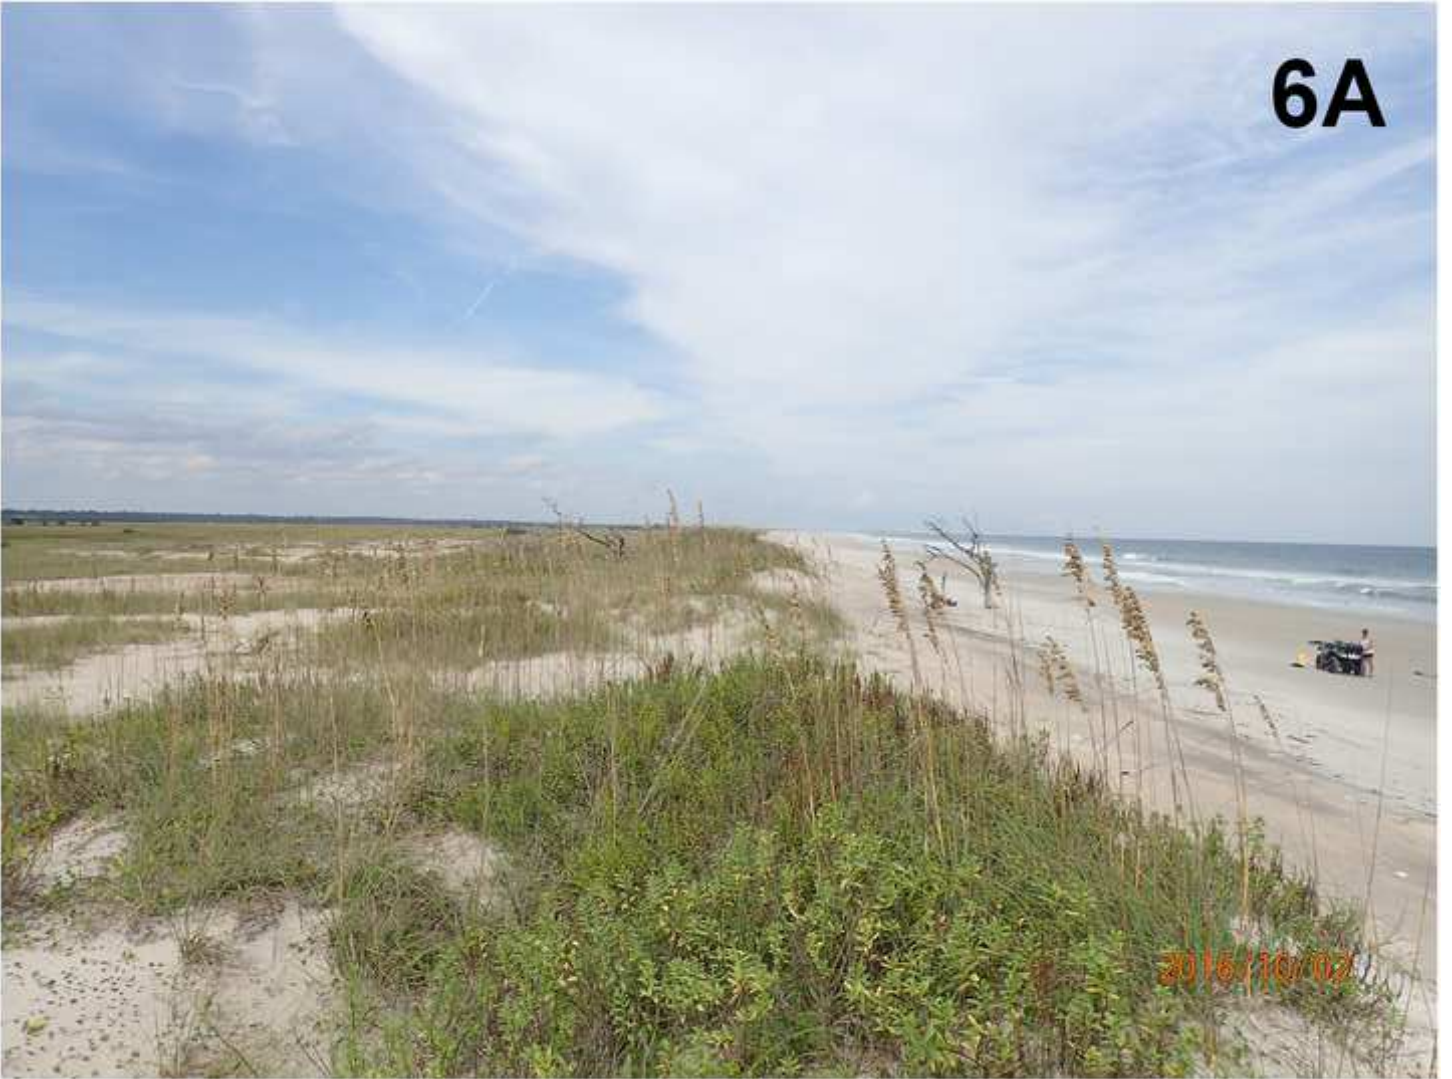
6A

305 These two locations are analyzed jointly because of their similar geomorphological  
306 characteristics and identical storm response. Pre-storm observations revealed a low-elevation,  
307 continuous to semi-continuous and moderately vegetated dune system backing the main beach  
308 (Figure 6A). There was evidence of previously overwashed sections, comprising narrow, infilled  
309 channels with minimal vegetation growth, which often extended across the width of the island  
310 (Figure 6B).

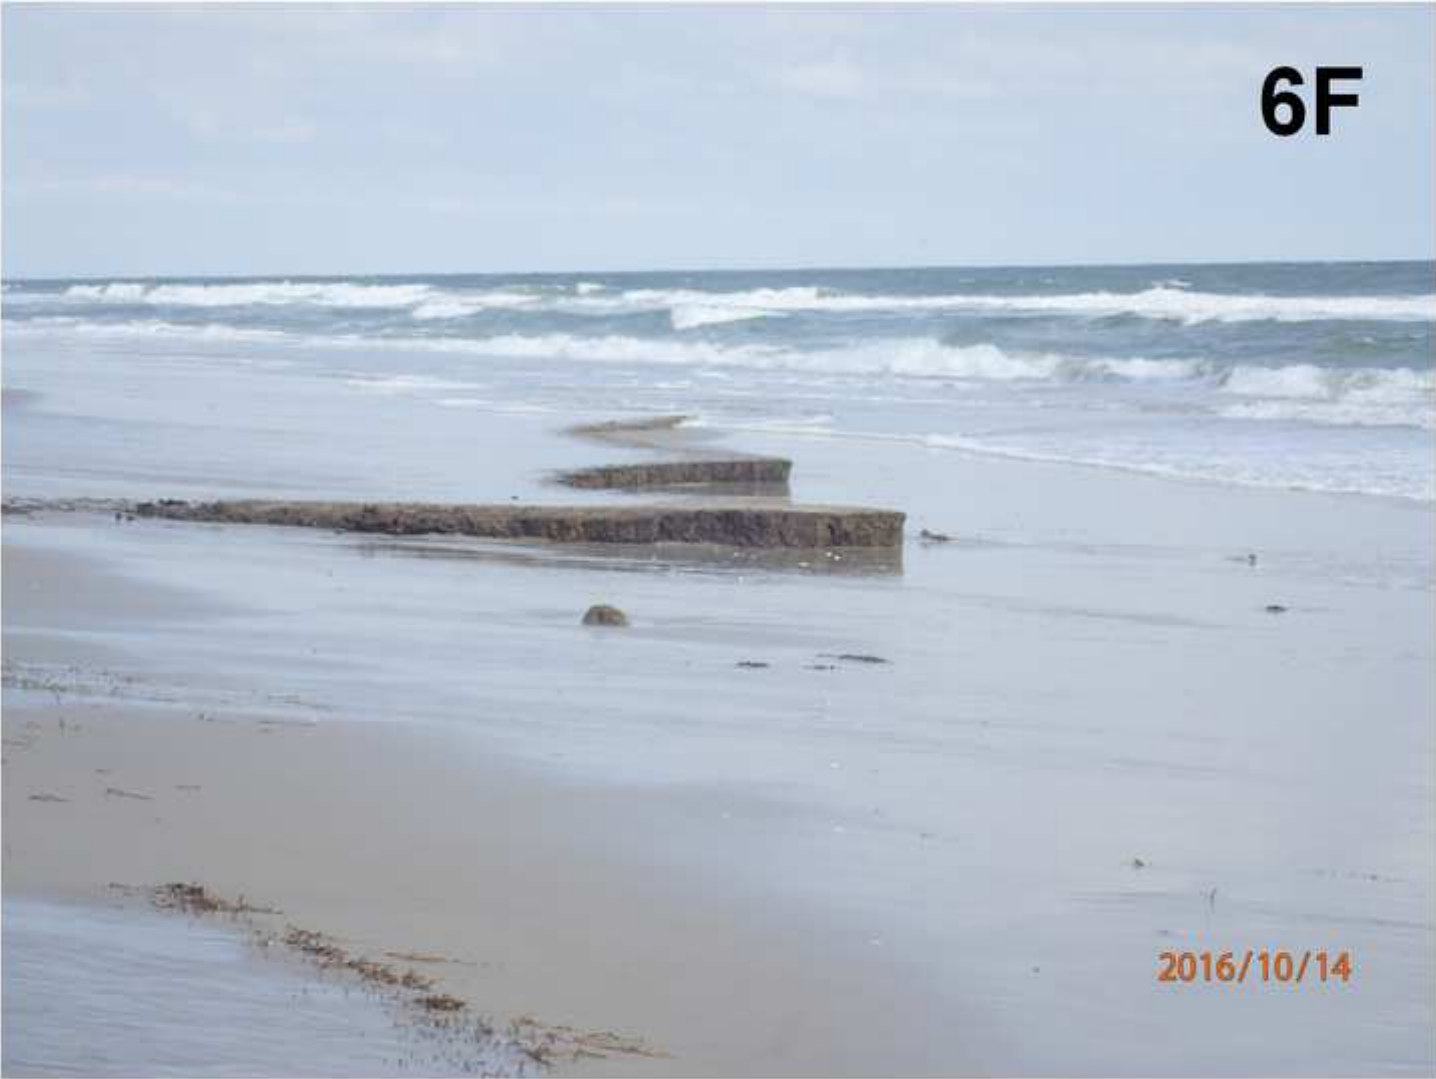
**6F**

1 311 A post-storm site visit, approximately one week after Hurricane Matthew, revealed significant  
2  
3 312 impacts to the beach, dunes and back-barrier areas at both locations. The intertidal beach was  
4  
5 313 significantly narrower and steeper and often overlain with coarse shell hash, shell fragments and  
6  
7 314 whole shells. The majority of the frontal dunes were severely eroded and vegetation cover was either  
8  
9  
10 315 stripped or buried (Figure 6C). Channel breaching was also widespread, especially where previously  
11  
12 316 infilled channels had been identified earlier (Figure 6D). The landward margin of the island had fresh  
13  
14 317 washover fans and terraces which extended into the adjacent marsh (Figure 6E). Coastal impacts were  
15  
16 318 particularly notable near MB02, comprising some of the lowest elevations along Masonboro Island.  
17  
18  
19 319 Other obvious storm impacts included exposure of underlying humate sandstone on the forebeach

20  
21 320 (Figure 6F), in addition to boulder-sized clasts of peat and *coquina* which were scattered across the  
22  
23  
24 321 island. Pre-storm elevations of the foredunes ranged from approximately 3.4 m to 2.6 m for MB01 and  
25  
26 322 MB02, respectively (Figure 7). The total width of the island at these locations was 90-100 m, with the  
27  
28 323 longer profile corresponding to MB01. The upper beach face and frontal dune was significantly  
29  
30 324 steeper compared to the sub-horizontal back-barrier region behind the main dune system. The  
31  
32  
33 325 landward margins of the beach often dropped steeply into the marshes at the back end of the island  
34  
35  
36 326 (Figure 7).

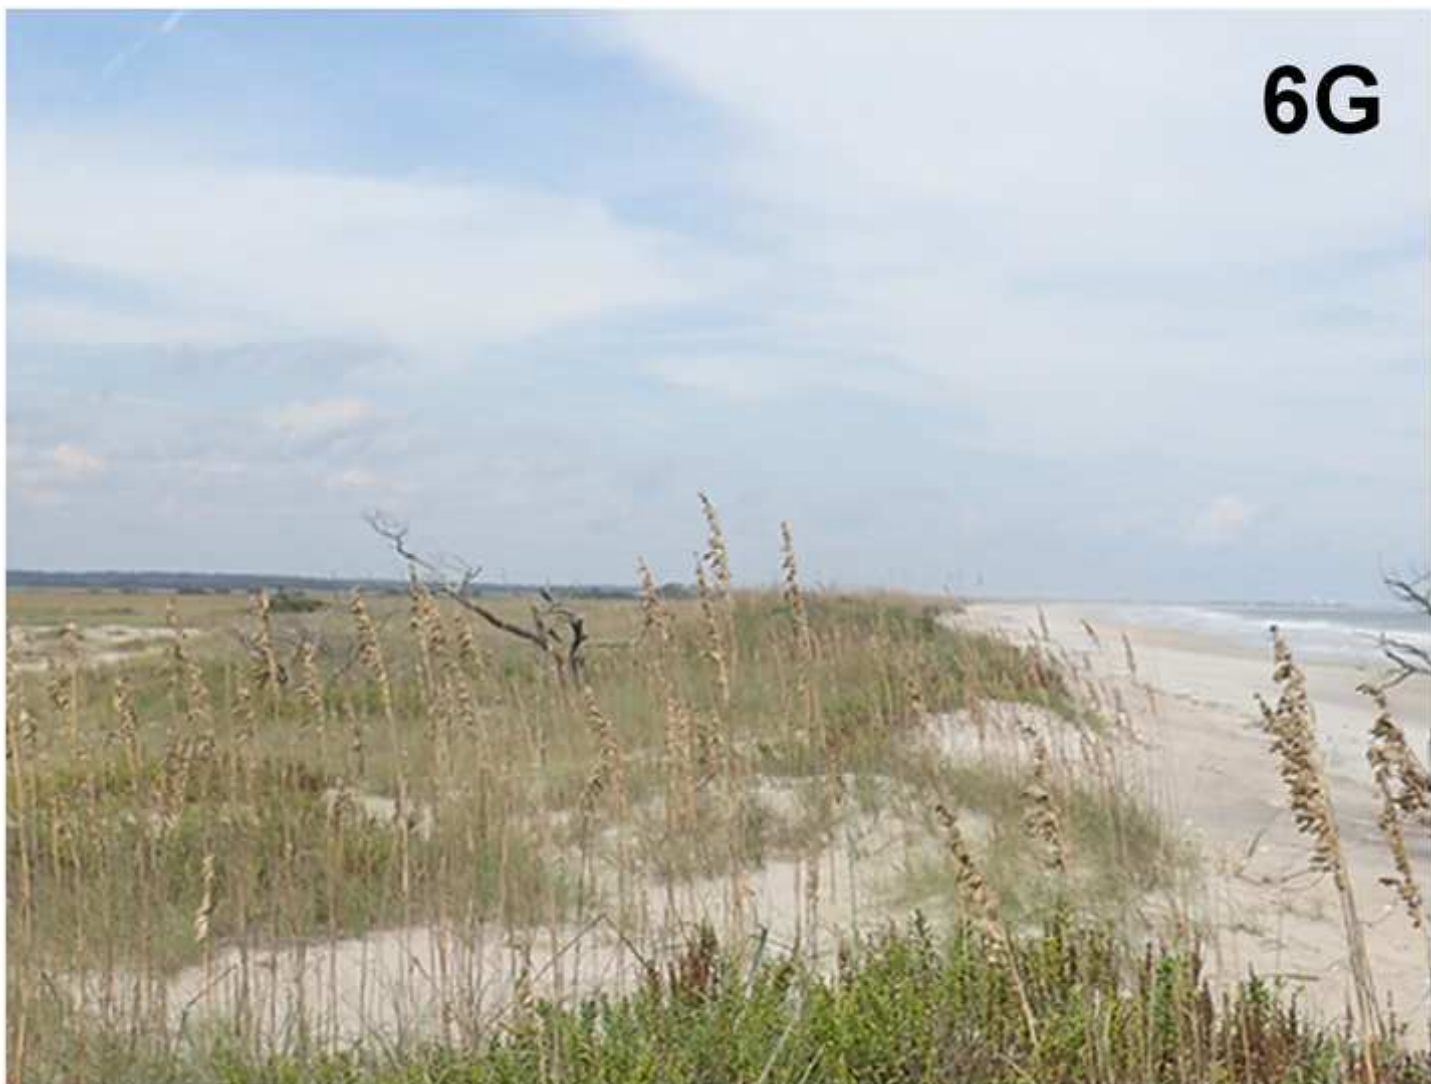
**6G**

14  
15 343 a long, wide beach face and extensive berm (Figure 6G). The frontal and main dunes were well-
